HERITAGE NEW ZEALAND
POUHERE TAONGA

New Zealand Heritage List/Rārangi Kōrero – Report for a Historic Place **Manor Place Conveniences, DUNEDIN (List No.9840, Category 2)**

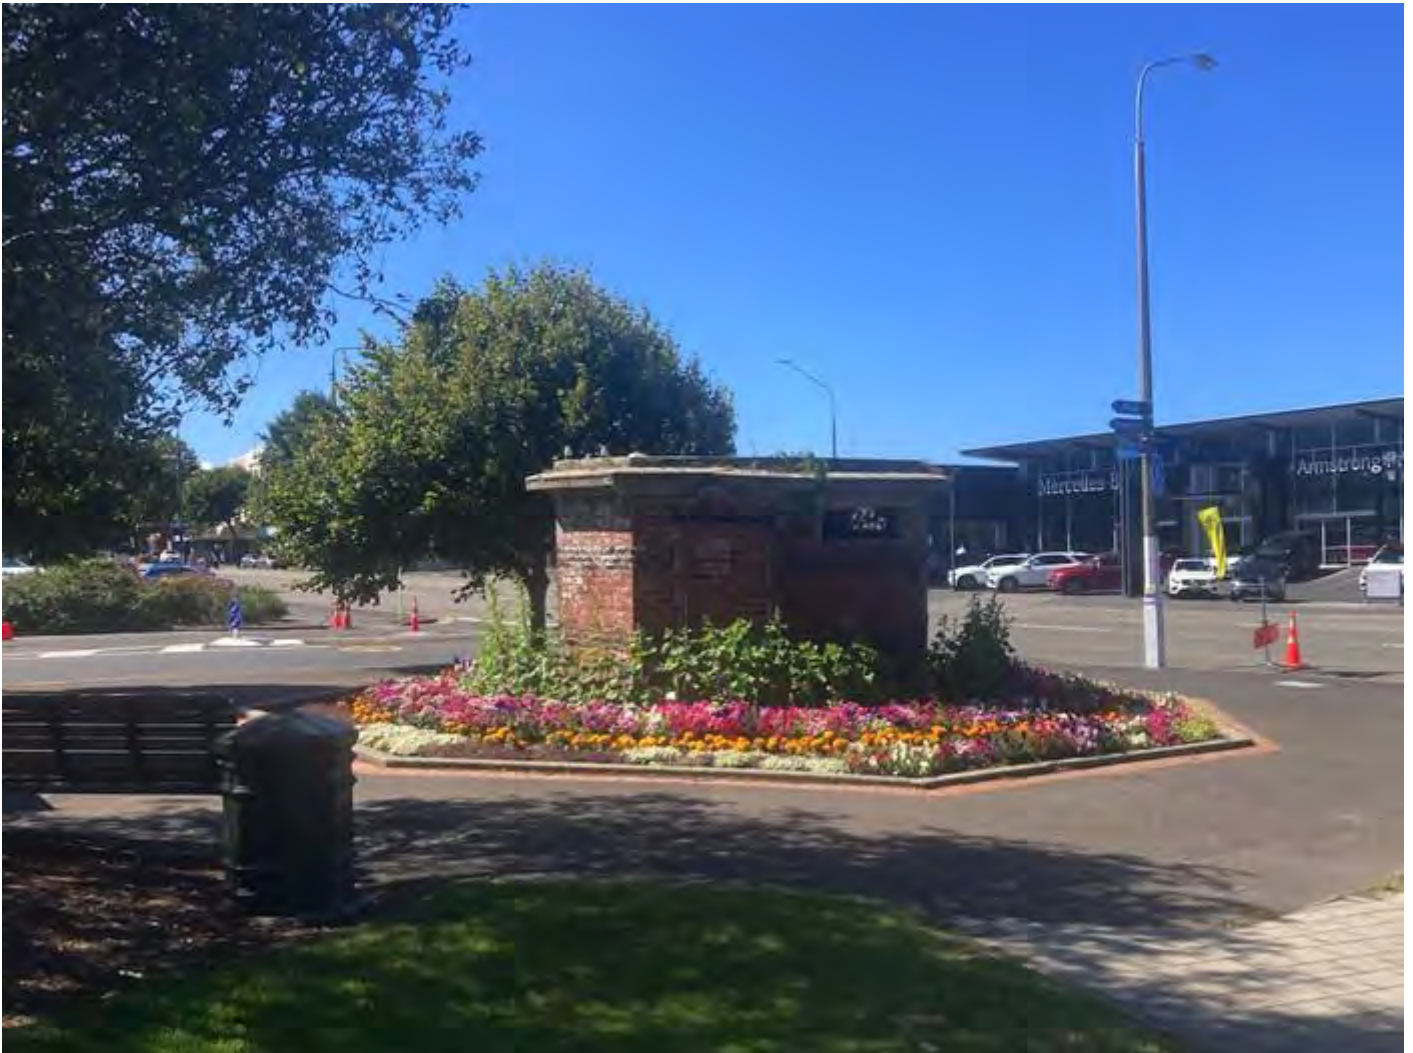
South elevation of Manor Place Conveniences, February 2023, photo by Alison Breese for Heritage New Zealand Pouhere Taonga.

The brick elevations, with 26 visible courses, features two bands of slightly darker-coloured, rusticated brick that break the monotony of the red brick facades. The bricks are laid in English Garden Wall bond with the rusticated bricks laid in Stretcher bond, and though unconfirmed, the mortar appears to be a cement mortar.¹⁰⁰ Once covered in ivy, this has

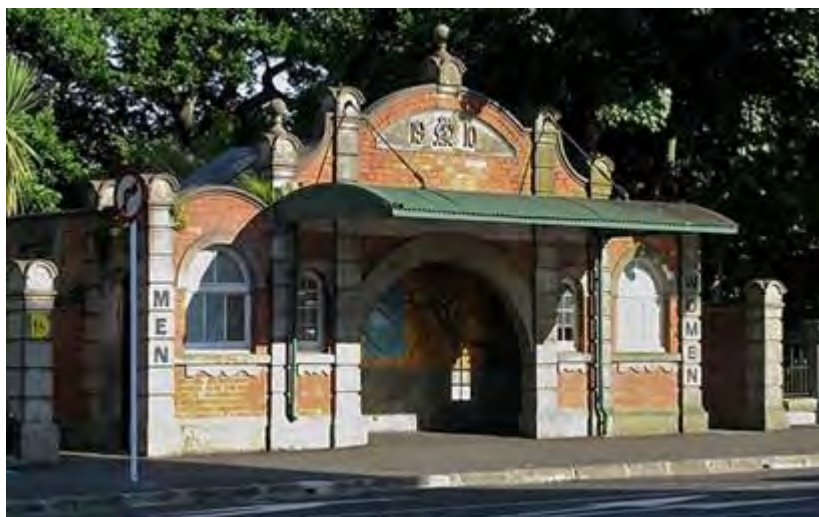
Bus Shelter and Toilets, Symonds Street and Grafton Bridge, Auckland (List No. 561)

Figure 1: Bus Shelter and Toilets, Auckland. Image courtesy of [www.flickr.com - https://www.flickr.com/photos/geoff-inoz/](https://www.flickr.com/photos/geoff-inoz/). Copyright: geoff-inOz. Taken By: geoff-inOz. Date: 12/11/2009.

This public convenience built in 1910 catered for men and women and also featured a tram stop.¹⁰⁵ These were built two years earlier and although brick, it is significantly different in its design to Manor Place. The interiors have similar white tiles to the Manor Place urinal, although are square rather than rectangular in shape. It has also been significantly modernised over the decades and has recently undergone restoration works and a seismic upgrade in 2022.¹⁰⁶

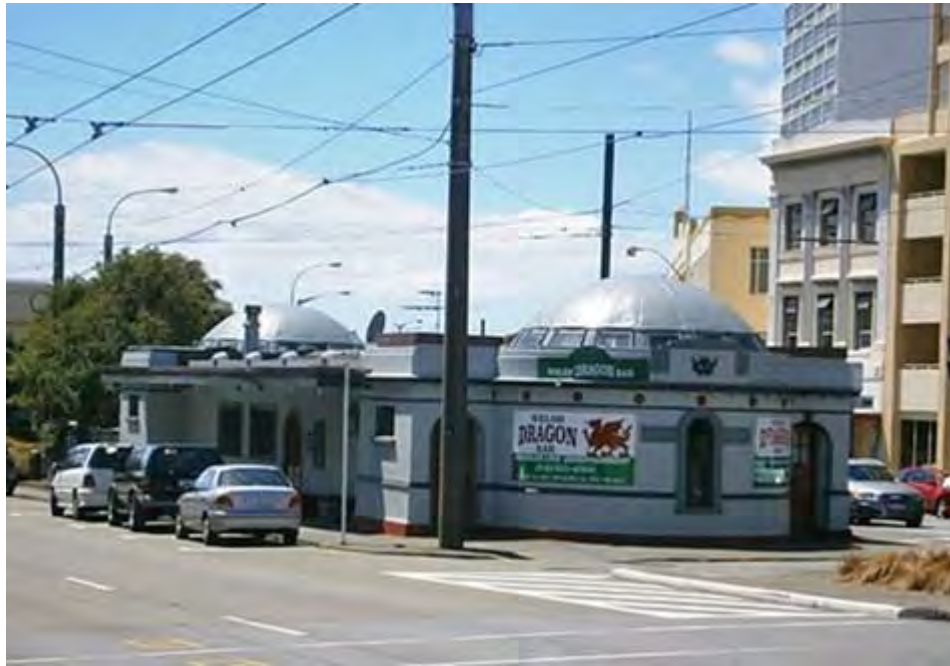
'Taj Mahal' Public Toilets (Former) List No 1434¹⁰⁷

Figure 2: 'Taj Mahal' Public Toilets (Former), Wellington. Image courtesy of rnfoster.com, Copyright: R.N. Foster. Taken By: R.N. Foster. Date: 9/02/2013.

The 'Taj Mahal' was built as a public toilet in 1928–29 and was bestowed its popular name from the distinctive domes at either end, reminiscent of the great Taj Mahal. It was designed by the City Engineer's office and built by Fletcher Construction. Unlike other public conveniences built at the time, this building was constructed above ground, and was part of a series of interesting public utilities designed by the Wellington City Corporation.¹⁰⁸ The convenience is rendered in reinforced concrete with a tiled mosaic floor and a Malthoid roof covering.¹⁰⁹ Similarities with Manor Place are that it is above ground, single storey with a semi-

circular row of urinals at the south end, it differs from Manor Place in its materials and the fact it was built for both men and women. The toilets closed in 1966 and since then has served multiple purposes including: storage, theatre workshops, art gallery and restaurant.

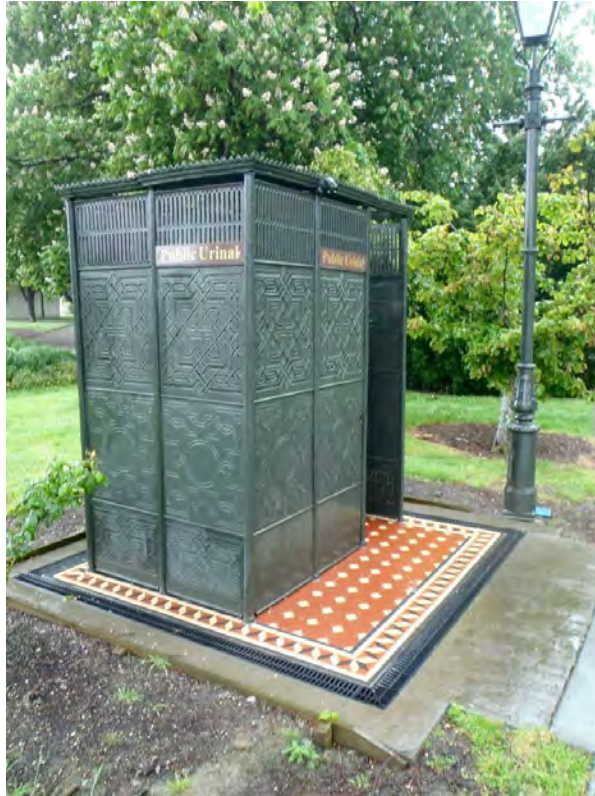
Masterton Cast Iron Urinal

Figure 3. Masterton Urinals 2015, Queens Park, Masterton, Photographer Robert McBride, awaiting permission ¹¹⁰

The cast iron urinal in Masterton was refurbished in 2012 after being in storage for many years.¹¹¹ No longer in its original position on the main street, it was relocated to Masterton Park and is believed to have been built in the early 1900s. As this was built of cast iron it was easy to move around unlike the permanent Manor Place brick structure. Many councils opted to have the cast iron style as it was inexpensive and could be easily shifted.¹¹² However, Dunedin City Council chose to build a brick one with the last of special funds money that had been allocated and used for the underground conveniences, in the Octagon, Customhouse Square, and London Street. The first iron public urinal manufactured in New Zealand was by Mr J. Storrier in 1903.¹¹³

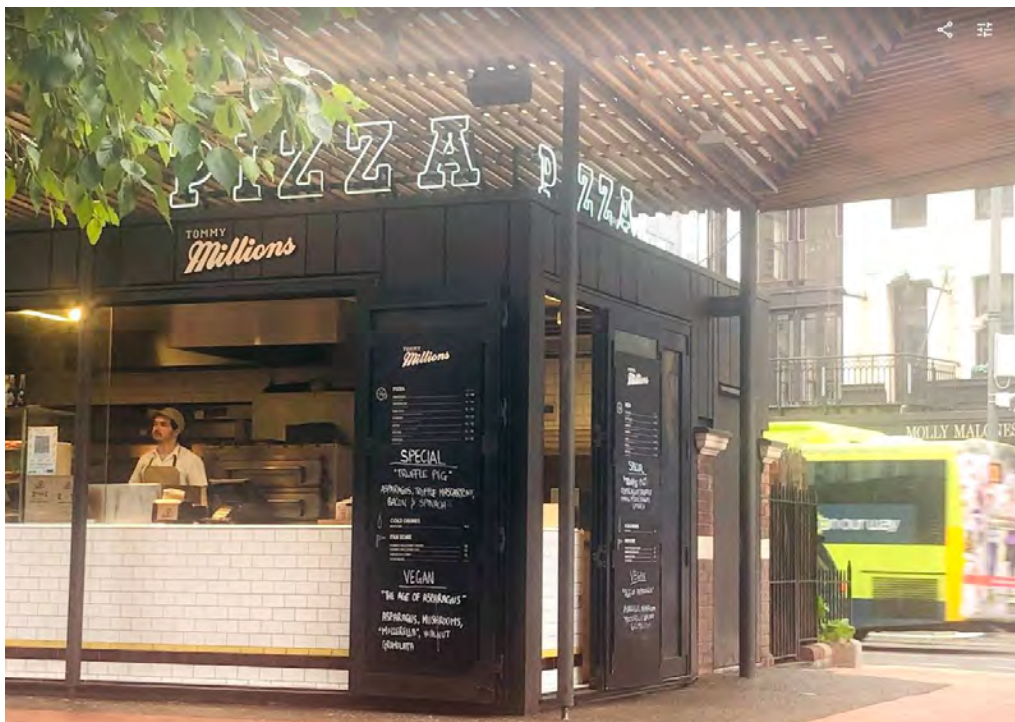
Courtenay Place Toilets (former), Wellington

Figure 4: Tommy Millions Pizza now leasing the former Courtenay Place Toilets, 21 November 2020, photograph by Alison Breese. Some of the tiles, fencing and original brickwork can still be seen.

The former Courtenay Place Men's Toilets are a good representative example of a utilitarian, local authority, Edwardian building. They were built in 1910, two years before Manor Place Convenience and they were semi-underground. The walls were constructed in brick with a concrete roof on steel joints. All walls, floor, and roof were covered with mineral asphalt with the floors also being coated with red arkilite. The toilets were more substantial than the Manor Place Convenience as it included six urinals, three toilets and an attendant's room.¹¹⁴ They were closed in 1994 after many years of complaints, making them one of the last underground toilets remaining in New Zealand. In 2011 the space was leased and developed into a pizza and gelato kiosk. All interiors were removed, and the cast iron fences, and the prismatic skylights were preserved by the Wellington City Council.¹¹⁵

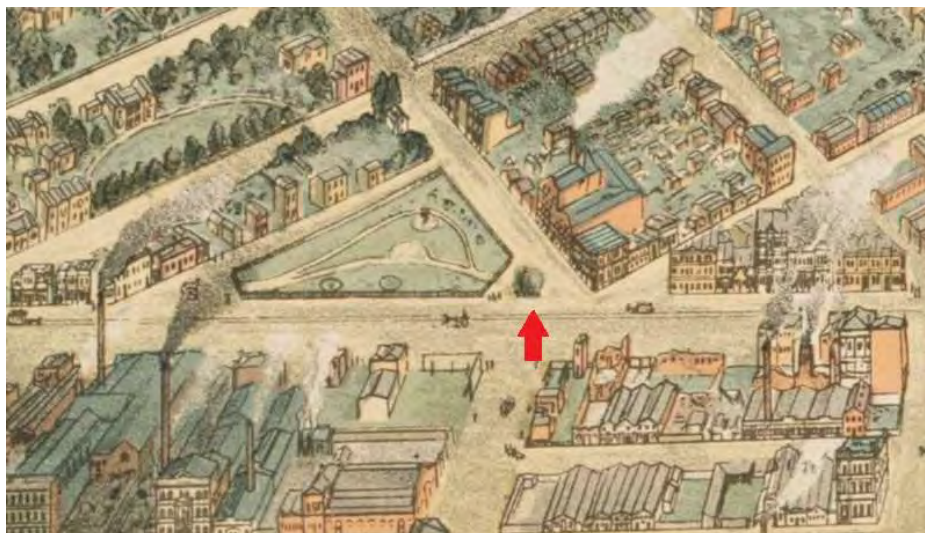
Figure 7: Detail from J Wilkie and Co map of Dunedin 1898 showing the Market Reserve with the location of the Manor Place Conveniences, Alexander Turnbull Library.

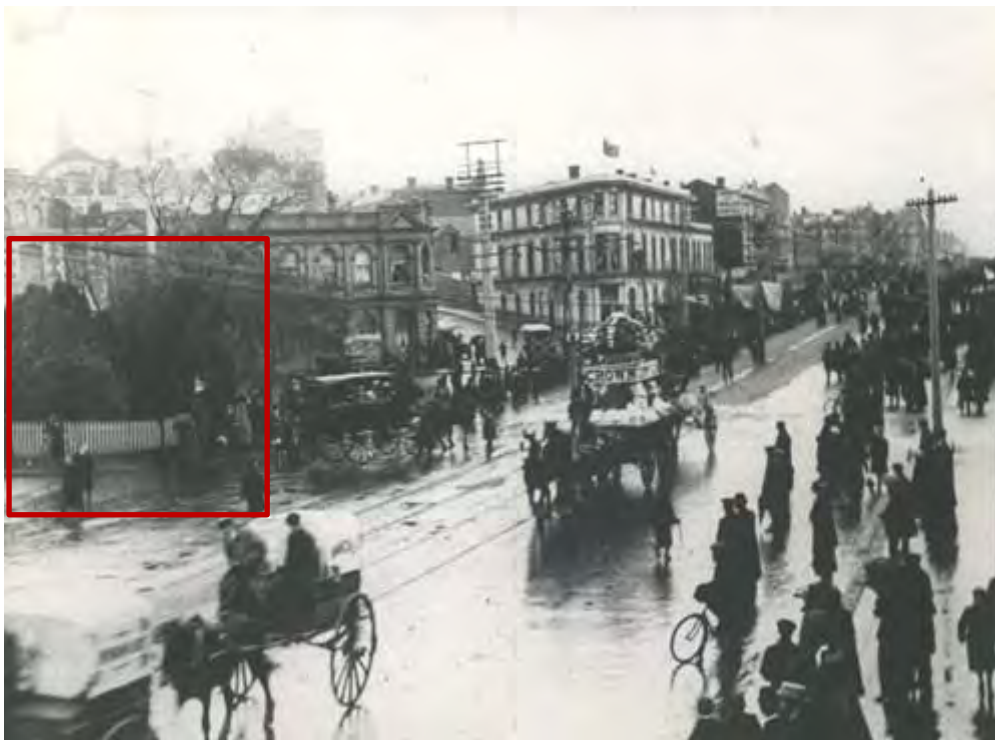
Figure 11: Corner of Princes Street and Manor Place, with the original Manor Place urinal to the extreme left, 1887, 0652_01_020A, Hocken Collections.

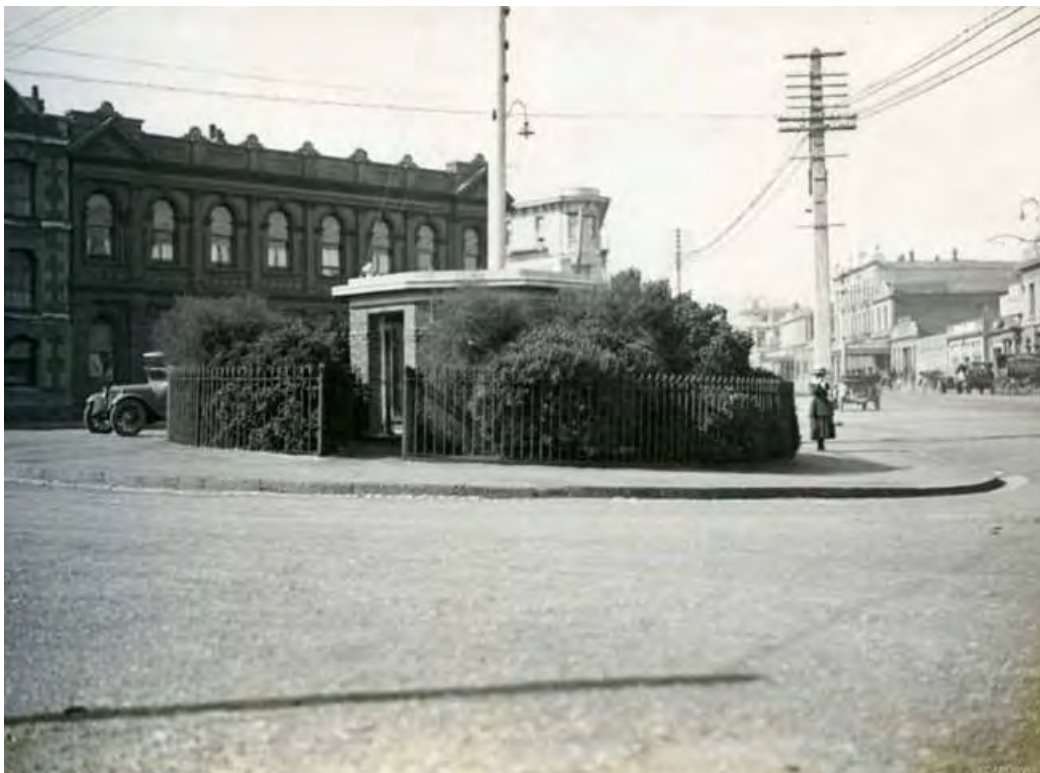
Figure 13: South elevation of Manor Place toilets c 1919, City Engineer's Department, City Engineers (CE) Correspondence Series 2, Volume 18, DCC Archives.

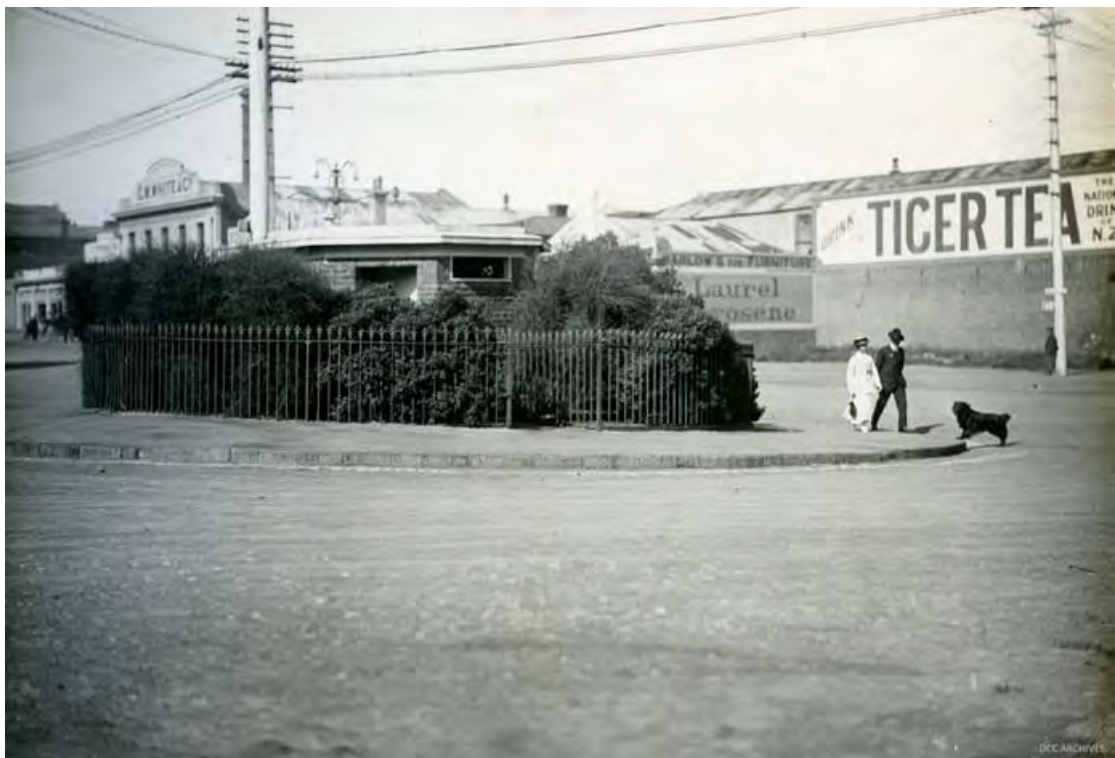
Figure 14: South elevation of Manor Place toilets c 1919, City Engineer's Department, City Engineers (CE) Correspondence Series 2, Volume 18, DCC Archives.

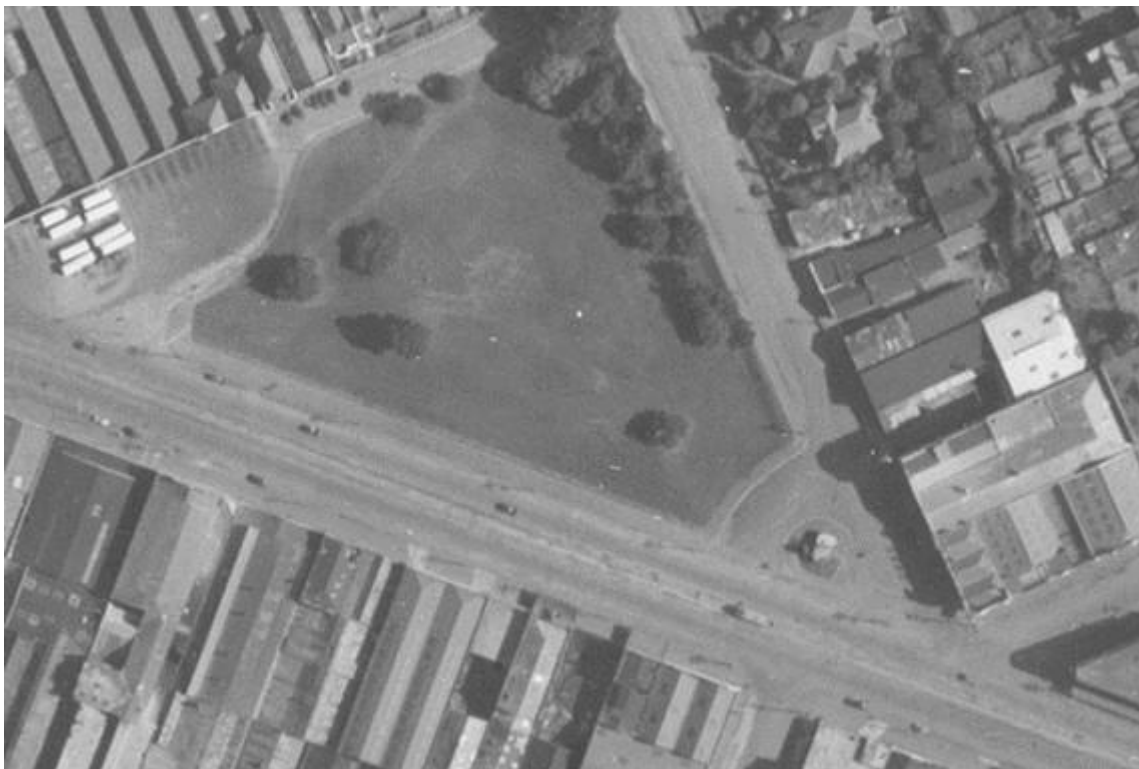
Figure 15. Detail from aerial photograph of the Manor Place convenience and Substation, 1947, SN399, P/50, www.retolens.co.nz.

In 1926 additions were made to the Manor Place urinal to erect a substation which were accepted by Council.⁷⁸ In 1957 the substation located at the back of the convenience was demolished with an underground substation being constructed to the side of the southern entrance of the building. The convenience was to be demolished too but somehow managed to escape this fate. The underground construction right next to the brick structure compromised the conveniences footings and repairs were made in 1958 to rectify the "sinking" of the convenience.⁷⁹ Along with the ground subsidence, drainage that ran under the floor was broken and the building was closed. It was argued by the City Engineer that it would be cheaper and easier to demolish both the substation and urinal at the same time and avoid the cost of repairing drainage.⁸⁰

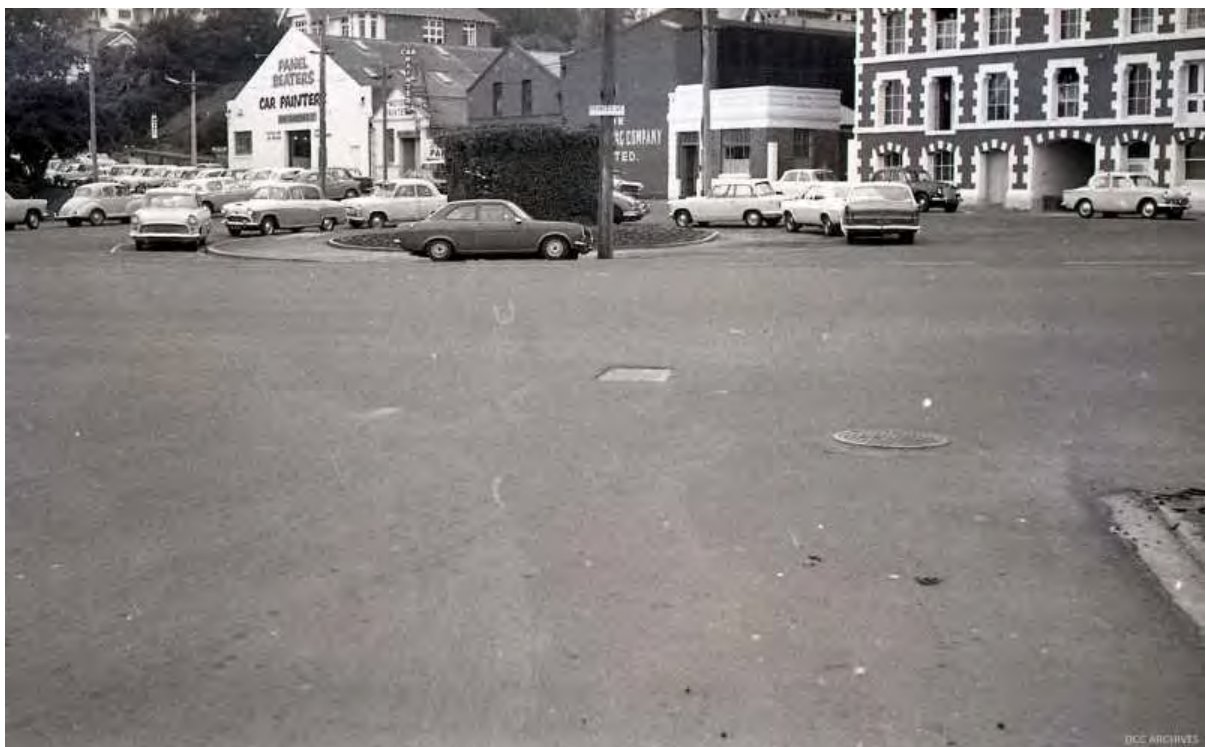
Figure 17: Manor Place Conveniences, c1975, Planning Department, Green Folder 'Central Business District', DCC Archives, DCC Archives.

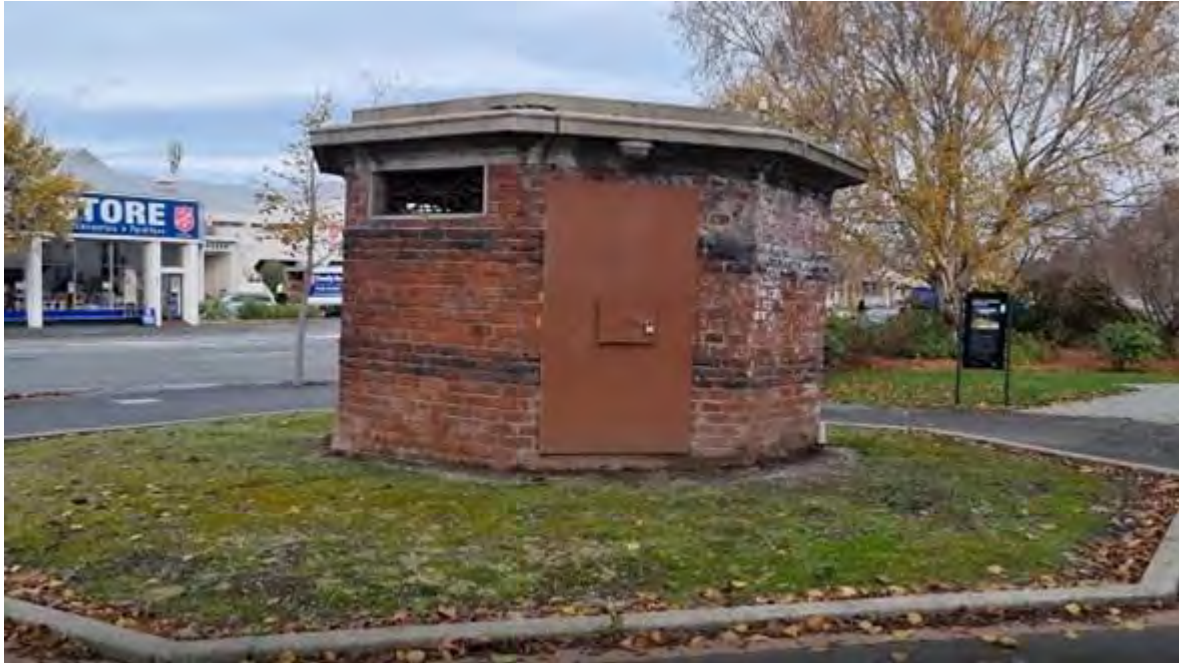
Figure 18: Manor Place Convenience 2022, north elevation viewed from Manor Place looking south, photograph by Rebecca Collie, Heritage New Zealand Pouhere Taonga.

An electrical pillar box for connection to mains power is located at ground level on the west elevation. Ad-hoc electrical fixtures can be seen on the roof and include a disused electrical insulator, a bracket for a former light, an aerial for a meter and an electrical conduit from the pillar box.¹⁰¹ There is a substantial, partially open crack through the brick masonry in the south elevation panel adjacent to the south screened opening.

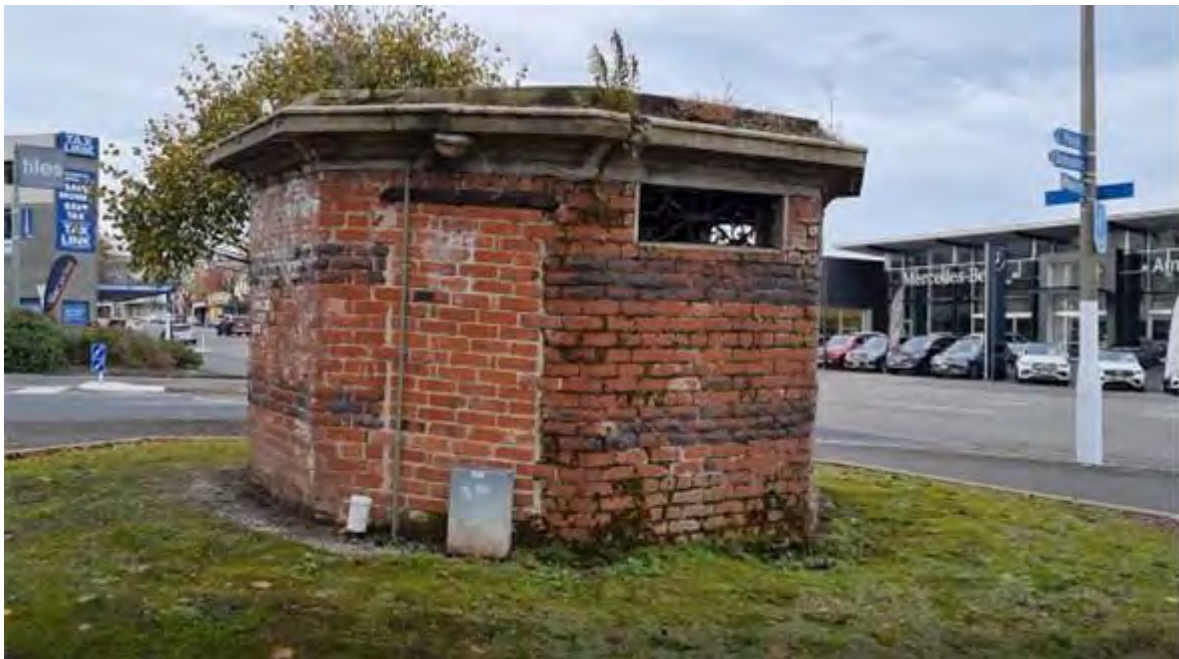
Figure 19. Manor Place Convenience 2022 south elevation, viewed from Market Reserve, looking north up Princes Street Photograph by Rebecca Collie, Heritage New Zealand Pouhere Taonga.

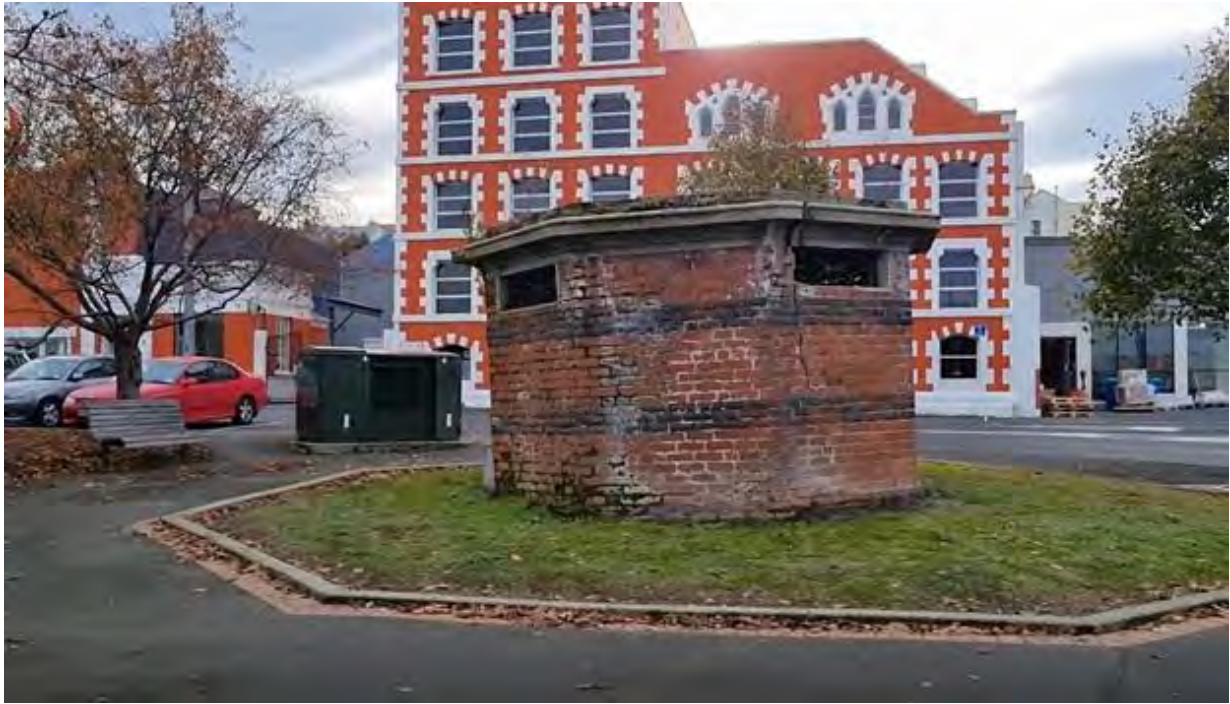
Figure 20: Manor Place Convenience 2022, south elevation, photograph by Rebecca Collie, Heritage New Zealand Pouhere Taonga.

subsidence under some of the urinal's footings.¹⁰³ The concrete floor was broken in 1958 for the remediation of broken drainage pipes.¹⁰⁴ Large cracks are prominent and seen from both the interior and exterior on the Princes Street side (southwest side) and the urinals have split at the joins. The decorative tiling is cracked in several places but predominately has remained intact although separated from the concrete roof. The interior walls have shifted, approximately 10cm, from their original placement and many are no longer be level. The cisterns are possibly from 1963 as they were replaced when a porcelain one was damaged; the previous brackets holes remain. There are small rough repairs to the fireclay urinals.

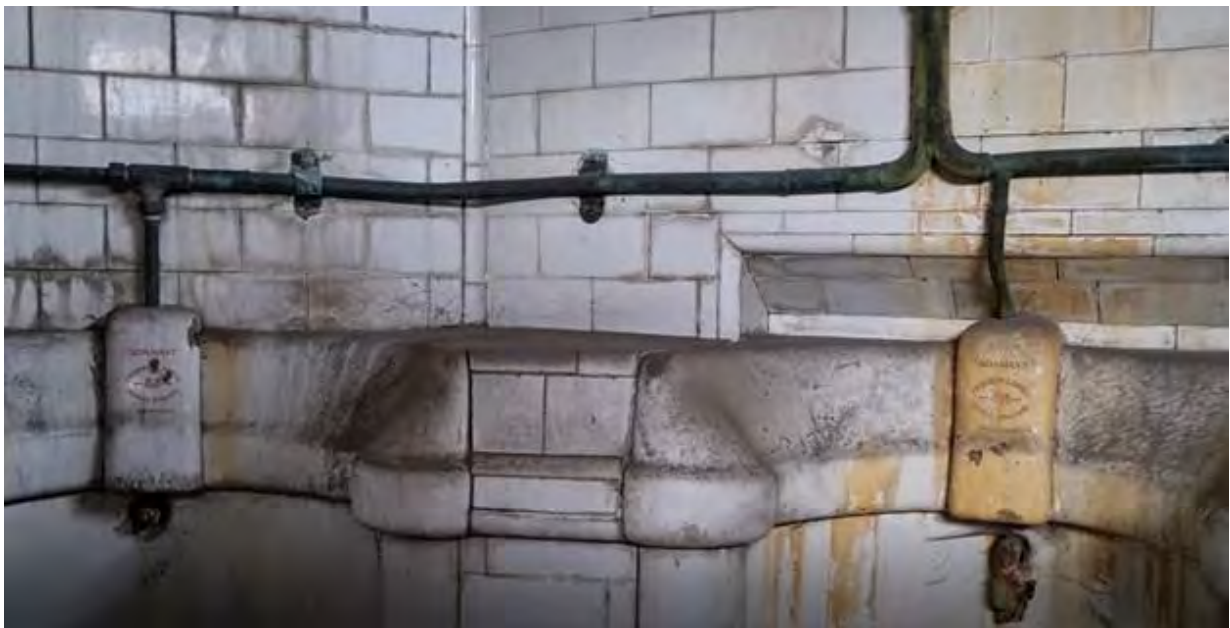
Figure 21: Manor Place Convenience 2022 interior view of Adamant urinals and wall tiles, photograph by Rebecca Collie, Heritage New Zealand Pouhere Taonga.

The interior has never been modernised with only minor repairs occurring to rectify damage from subsidence and vandalism. The original Adamant fireclay urinal is still present as is the original wall tiles, decorative frieze and dado. The removal and subsequent placing of an underground substation next to the structure resulted in some damage due to ground

The placement of the 'Adamant' urinal differs from both the Twyford catalogues and from other conveniences built in Dunedin and across New Zealand. This design was to incorporate as many urinals into the small space as possible. The internal layout and design have only received minor damage by vandals over the decades and has never been remodelled or upgraded.

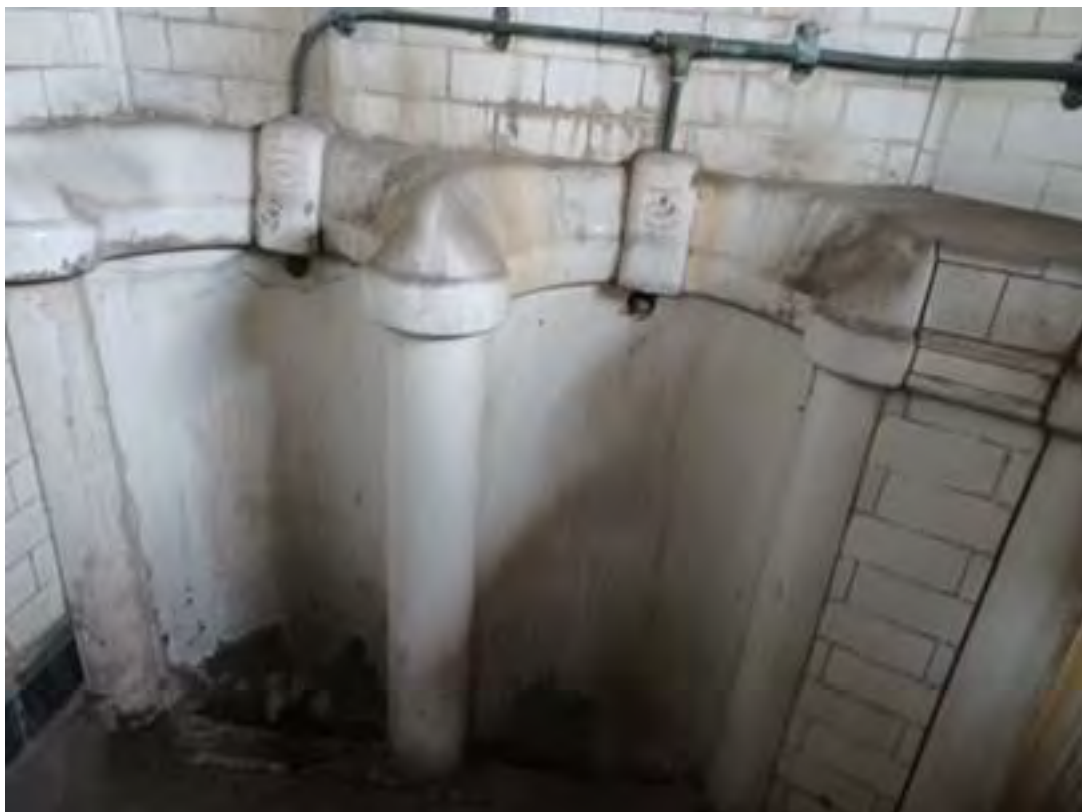
Figure 22: Manor Place Convenience 2022 interior view of urinals, photograph by Sarah Gallagher, Heritage New Zealand Pouhere Taonga.

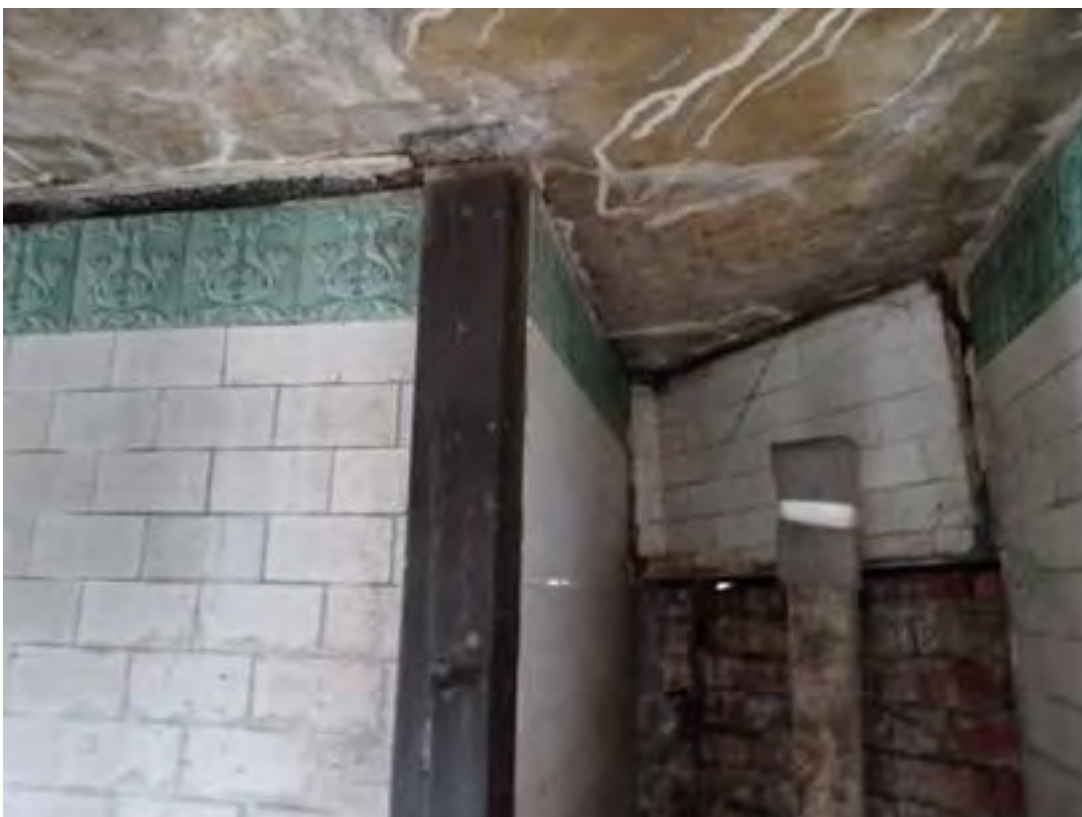
Figure 23: Manor Place Convenience 2022, showing wall tiles and decorative art nouveau tiles, photograph by Sarah Gallagher, Heritage New Zealand Pouhere Taonga.

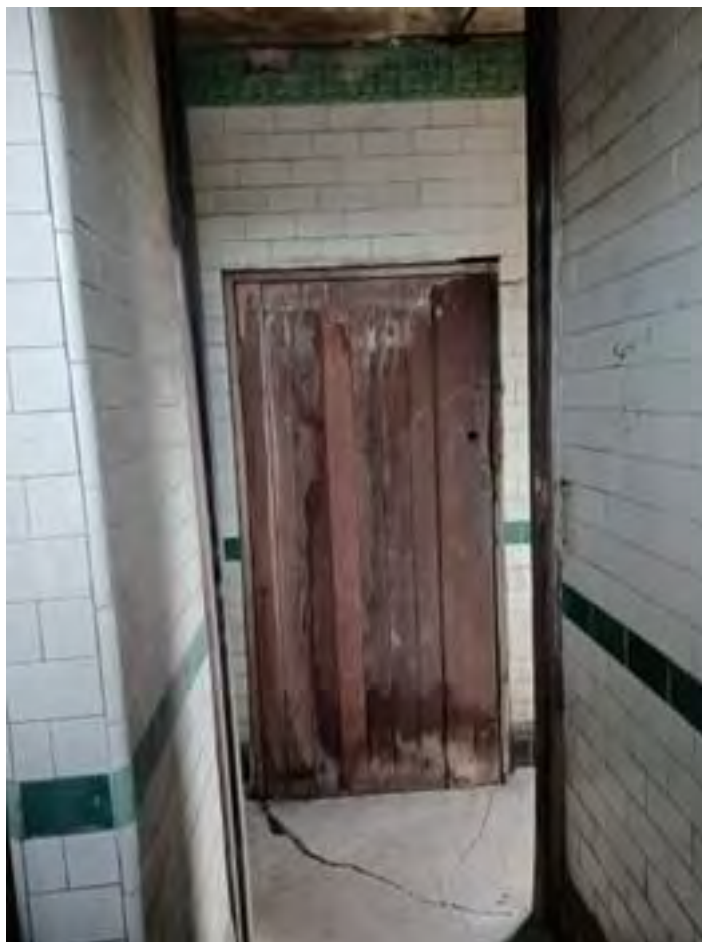
Figure 29: Detail of Locker door, Manor Place Convenience 2022, photograph by Sarah Gallagher, Heritage New Zealand Pouhere Taonga.

The structure has an entrance and exit corridor with a small locker on the southern side. Behind the wooden door into the locker there is an etched date of “12/12/12” in the concrete, presumably by one of the original contractors. One entrance on the southern side was bricked up possibly from the early 1960s and the other north facing entrance was bricked up sometime after 1985 (nothing has been found in archives about this work).¹⁰² The north facing entrance was opened by removing the recent bricks in 2017 to gain access for Dunedin City Council to assess potential work on the space.
