# Antrim House

*63 Boulcott Street, Wellington*

## CONSERVATION PLAN

R&D Architects Limited  
in conjunction with  
Bay Heritage Consultants and  
SPK Consultants Limited

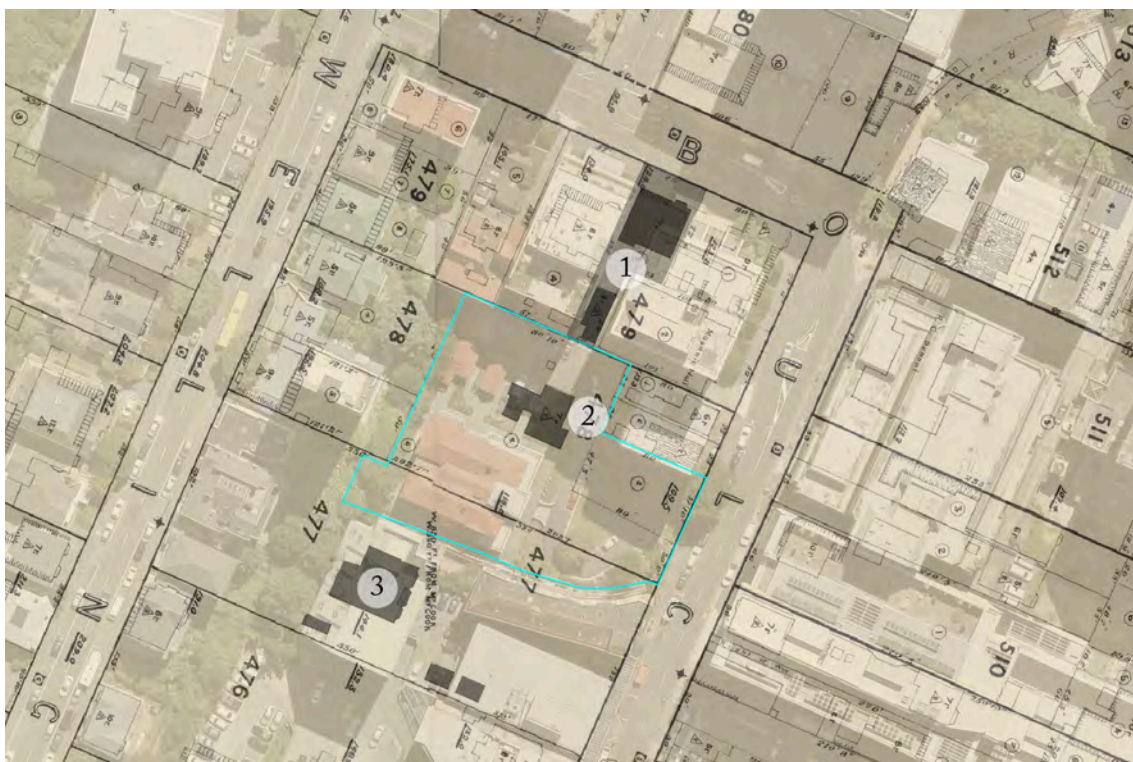
*Extract from the Thomas Ward Map, 1891 (superimposed over modern satellite photo, with red roof of Antrim House and accessory buildings shown, and the present site boundaries outlined in cyan). Antrim House was built across the boundary of Section 477 and 478, 15 years after this map was made. Key: (1) Additional section containing two houses, owned by Hannah family from 1929 (2) House demolished to make way for Antrim (3) Tera Tangata, the Hannah family's previous house. Thomas Ward Map, 1891, Wellington City Council.*

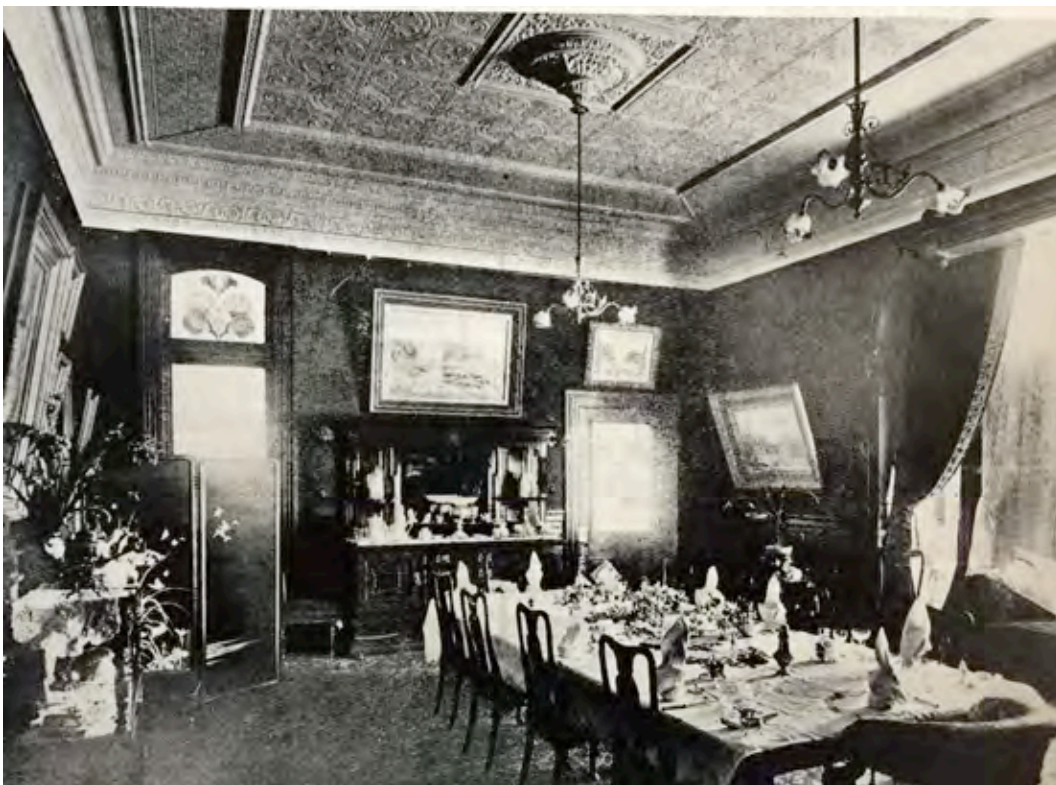
*The Hannah's dining room (now Records Room/Reception), 1906. Briscoe's catalogue c1907, taken from Attwell, p31. Note the door to the billiard room on the right, and the window topped with a leadlight that was made internal by the addition of the billiard room [the window was later removed]*

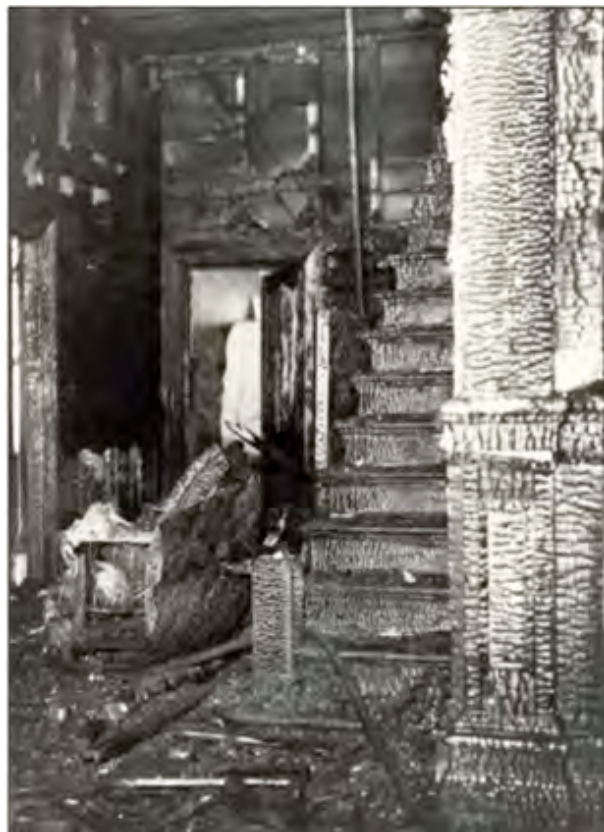
*The remains of the tower staircase after the fire, 1940*

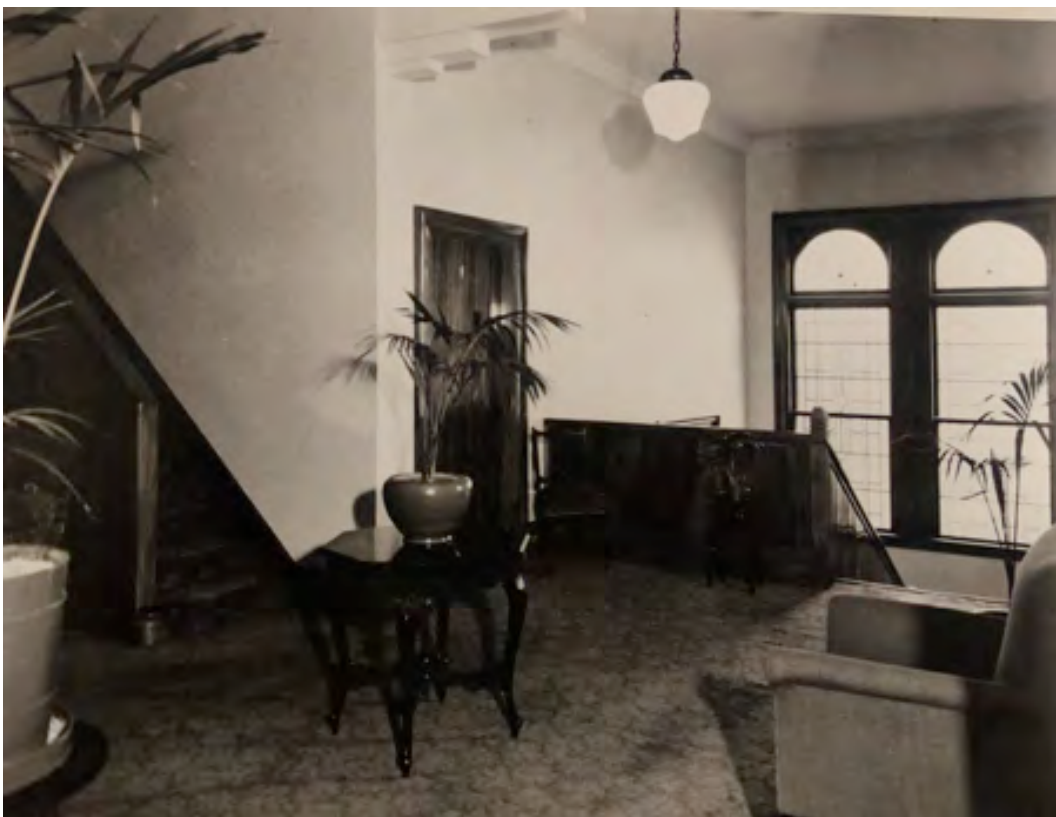
*Top of the stairs as repaired after the fire, 1948/49. Note the two staircases, now with solid balustrades, and the Art Deco-style ceiling cornice. HNZPT Collection*

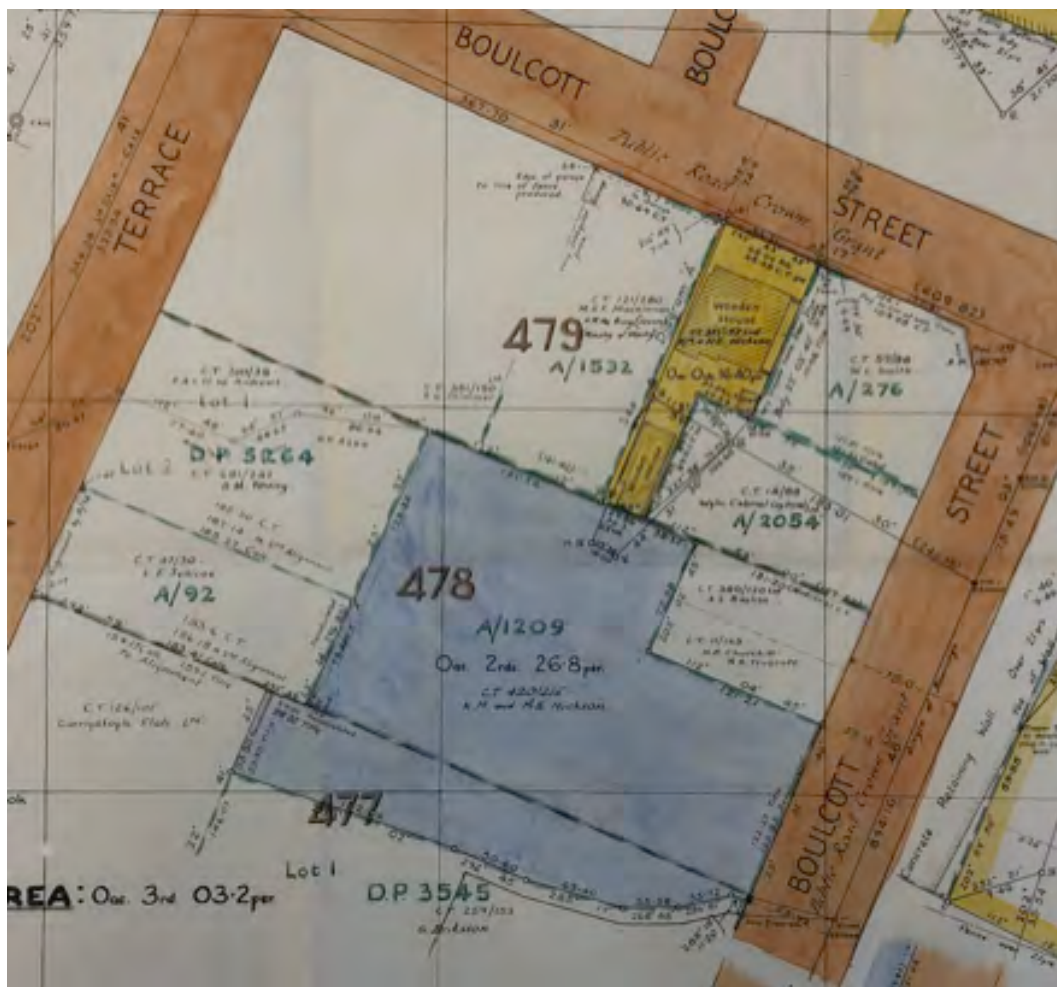
*SO 22120, 1950, Wellington Land District. The cottages were 91 and 91A Boulcott Street, marked on the title plan in yellow, with the Antrim site in blue*

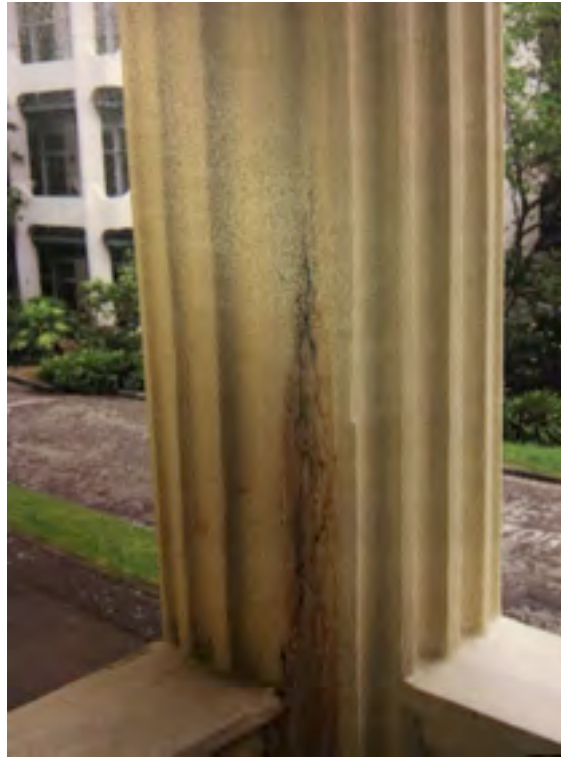
*Water damage to the verandah columns as a result of the failed deck membrane above, 2009.*

One of the key tasks was waterproofing the leaking first floor and tower decks. This involved removing the Nuralite membrane roofing from 1969 (which contained asbestos) and replacing it with a new liquid applied waterproof membrane (Chevaline Dextx). The old membrane had been leaking for a long time, and significant consequential repair work was required to the deck framing, some of the fluted columns underneath and the pediments above the windows. When these pediments were opened up, it was discovered that four were replacement pieces made of sheet metal (likely installed as a consequence of decay caused by leaks in the previous deck membranes) and these were replaced with new timber pediments to match the originals. The timber shingle roof on the tower was completely replaced with new treated radiata pine shingles over the existing sarking. Parts of the ground floor verandah deck were repaired at the same time.

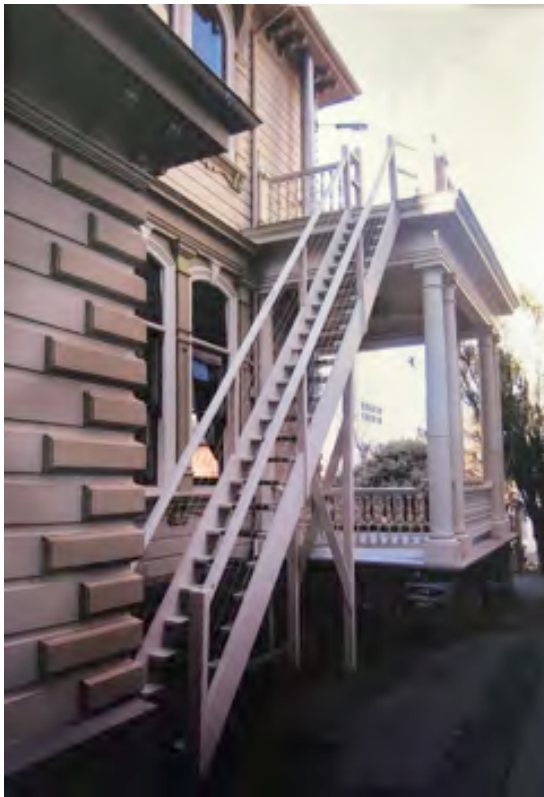
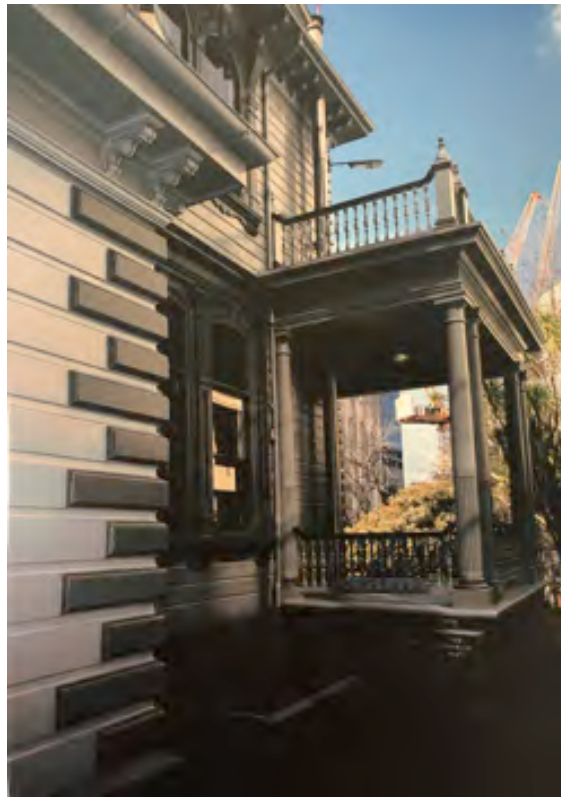
*Before and after the removal of the fire escapes on the southern façade, and reinstatement of missing balustrades and repainting, in 2009. HNZPT Collection*

A report by fire engineer Peter Byrne confirmed that the fire safety provided by the automatic sprinkler system satisfied the requirements for the safe escape of building occupants and determined that the external fire escapes were redundant, so these were subsequently removed from the building, returning it to an uncluttered appearance reflective of the Hannah era. The missing sections of the balcony balustrades, which had been docked off to fit the fire escapes, were reinstated.<sup>102</sup>

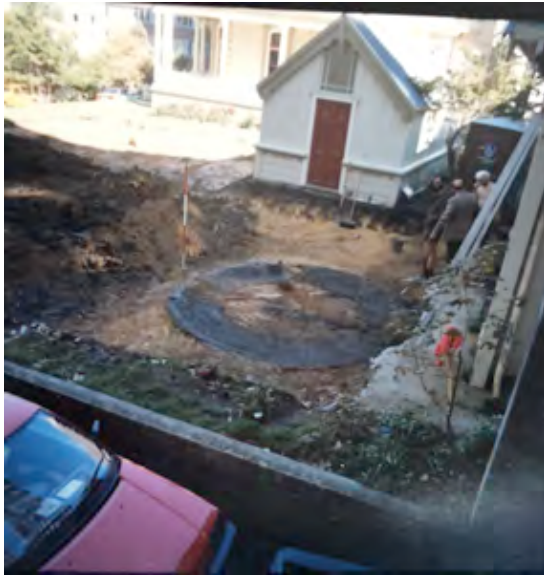
*The remains of Robert Hannah's car turntable, rediscovered in 1987. File Ref 13002-023 D, HNZPT file.*

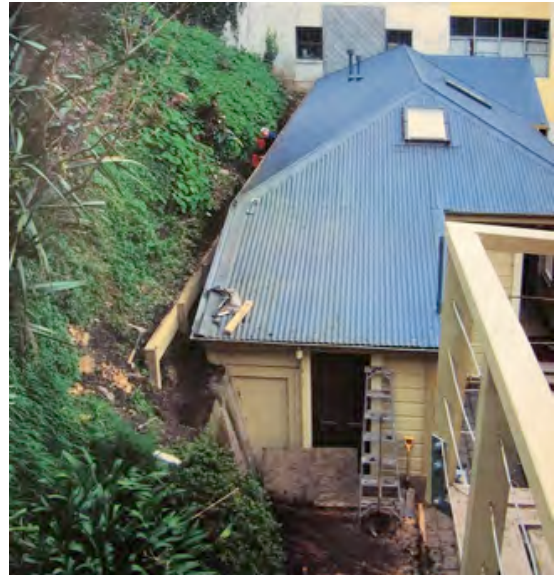
*Work to build a new retaining edge and drain to intercept surface water from the top of the bank at the stables, 2005. HNZPT file.*

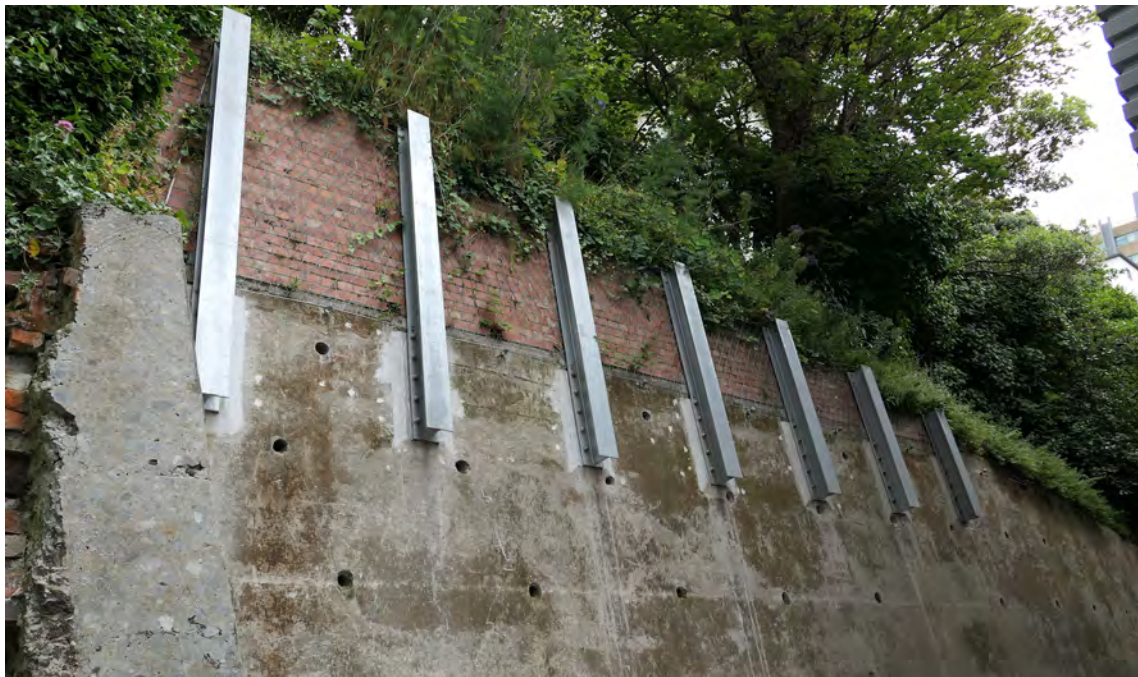
*2018 securing work to the brick wall on top of the west retaining wall.*

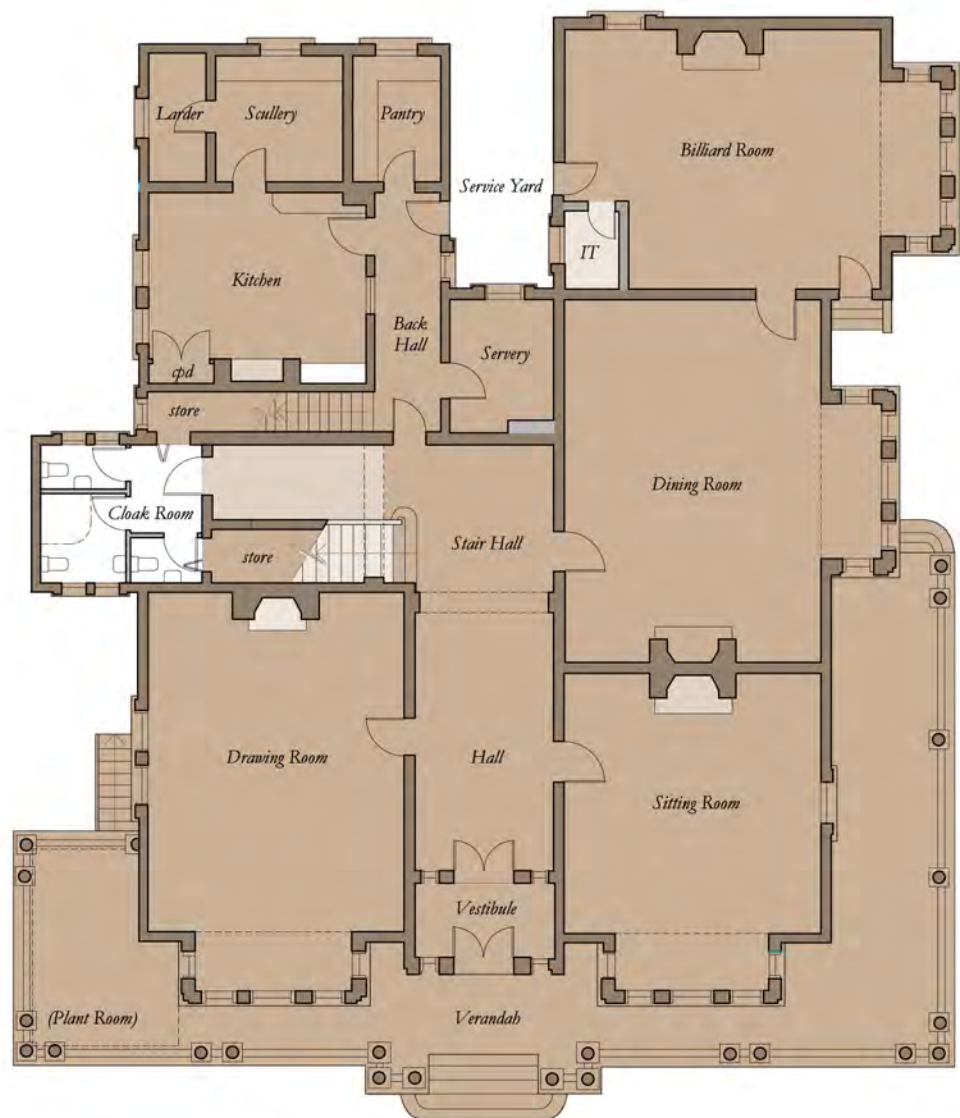
Summary of Heritage Values – Ground Floor

The relative heritage significance of all the spaces in each of the buildings is shown on the summary plans on the following pages (north to the right of the page). A set of reference plans is included in Appendix 1.

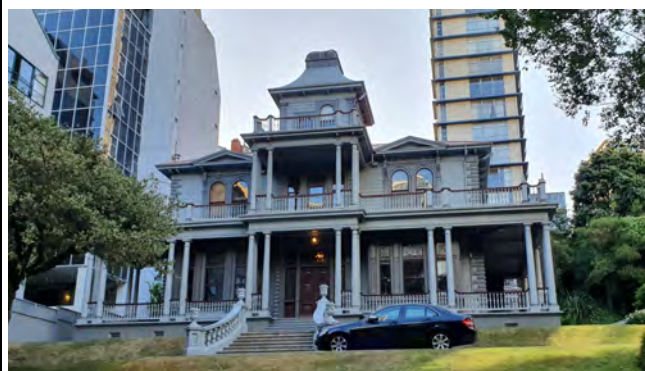
**Overall Form of Building**  
Heritage Value: 1

The complex external form of the building remains substantially as it was when it was first constructed, showcasing both William Turnbull's considerable design skills and Robert Hannah's imposing wealth.

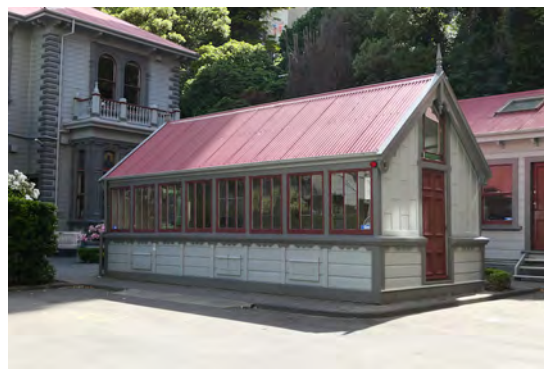
**Form of Building and Exterior**  
Heritage Value: 1

In the mid-1930s the Wimberleys converted the glasshouse to two accommodation rooms, changed the original glass roof for a malthoid roof and added the door at the north end. The building was further upgraded for staff accommodation in 1985; the malthoid roof was replaced with galvanised steel and the interior partition was removed to leave a single open space.

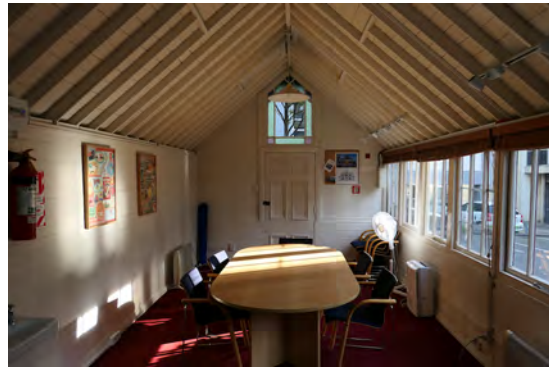
**Interior**  
Heritage Value: 1

The interior is largely representative of its state in the 1930s. It is a single volume with an exposed 'cathedral' ceiling showing the original roof framing. The walls are lined with horizontal tg&v timber; except on the west wall the linings are in two planes, one over the timber wall base and another over the backs of the window sashes. The floor is timber framed.

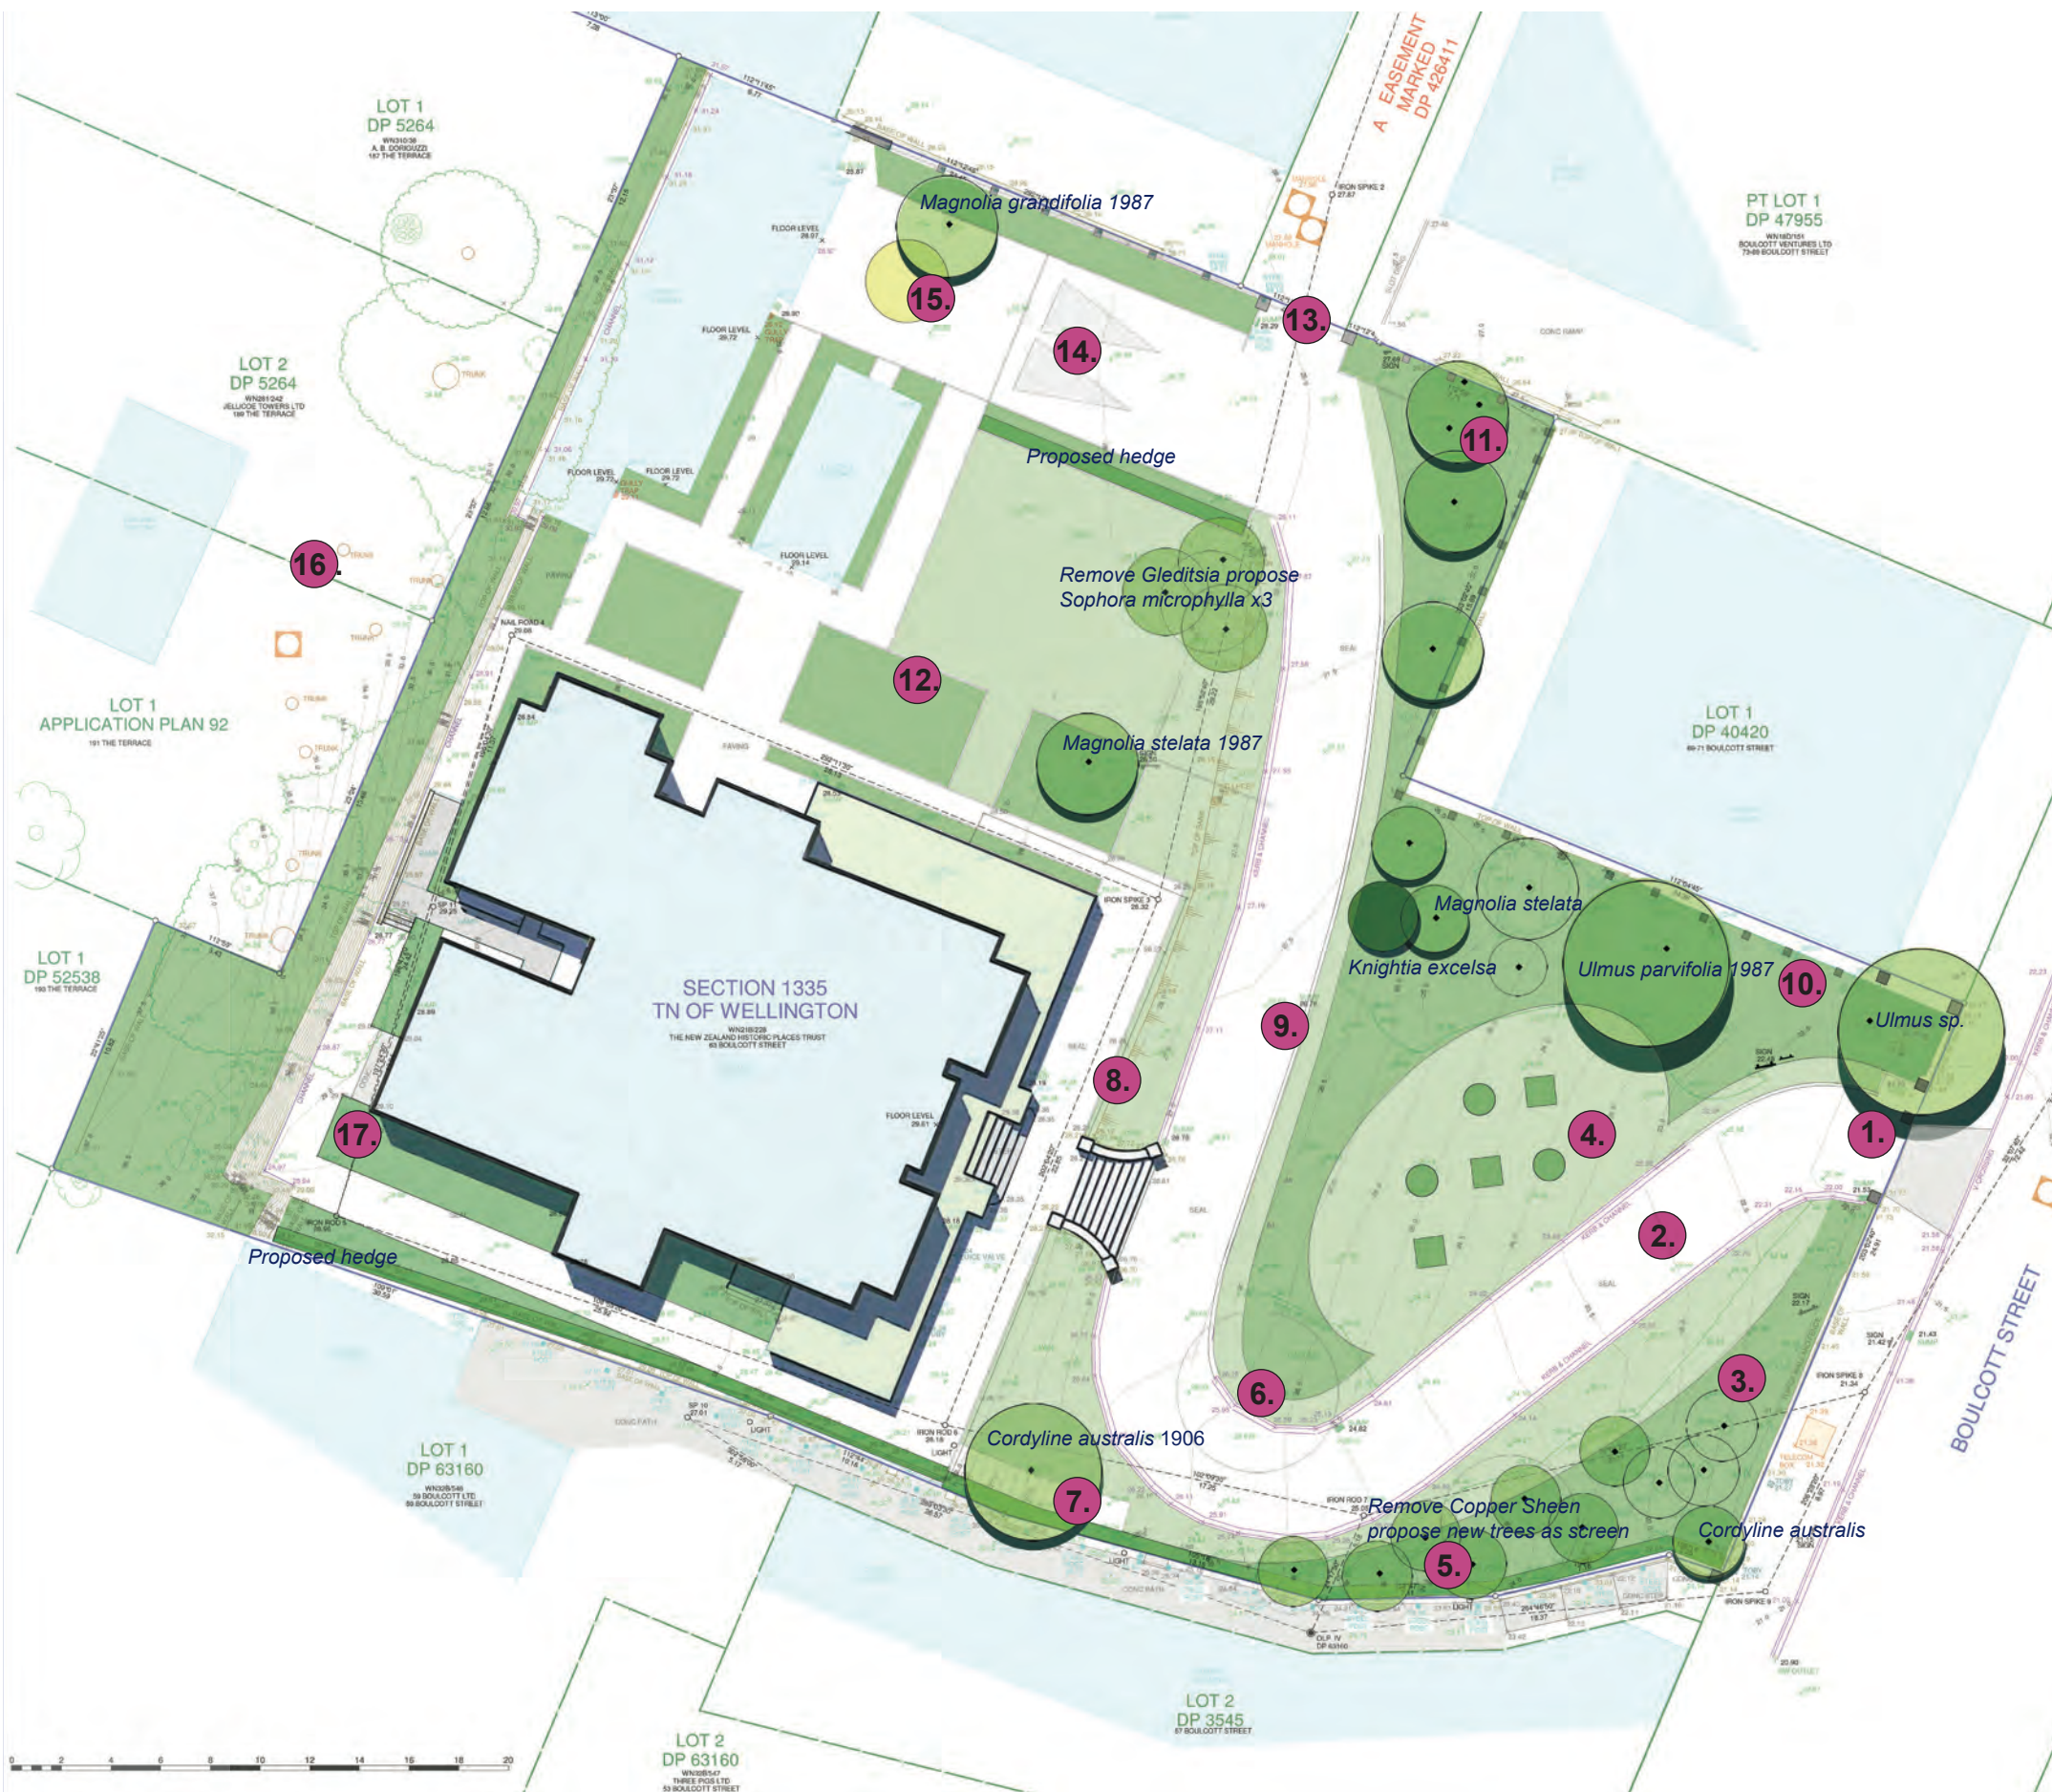
## LANDSCAPE RESTORATION

1. Front Gate - reinstate front entry gates and posts, review vehicle crossing threshold.
2. Driveway - progressively remove parking and reduce driveway width back to 2011 survey, reclaim lawn area between driveway and garden.
