# Turnbull House

*25-27 Bowen Street, Wellington*

## CONSERVATION PLAN

Revision No. 2, 17 August 2017

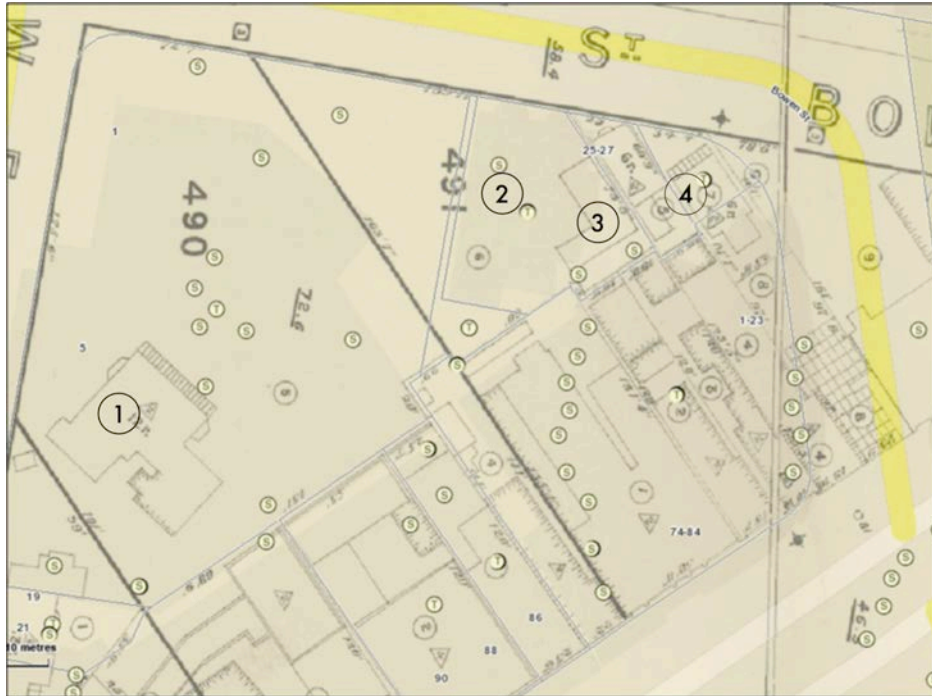
Detail of Ward Map 22, 1891 showing Town Acres 490 and 491 and numerous buildings along Lambton Quay. This shows (1) Elibank, (2) the footprint of Turnbull House (shaded), (3) the L-shaped building, possibly a garden shed (which may have been Turnbull's first museum) and (4) the land that was added to the Turnbull House grounds in 1930 (WCC WebMap, June 2017)

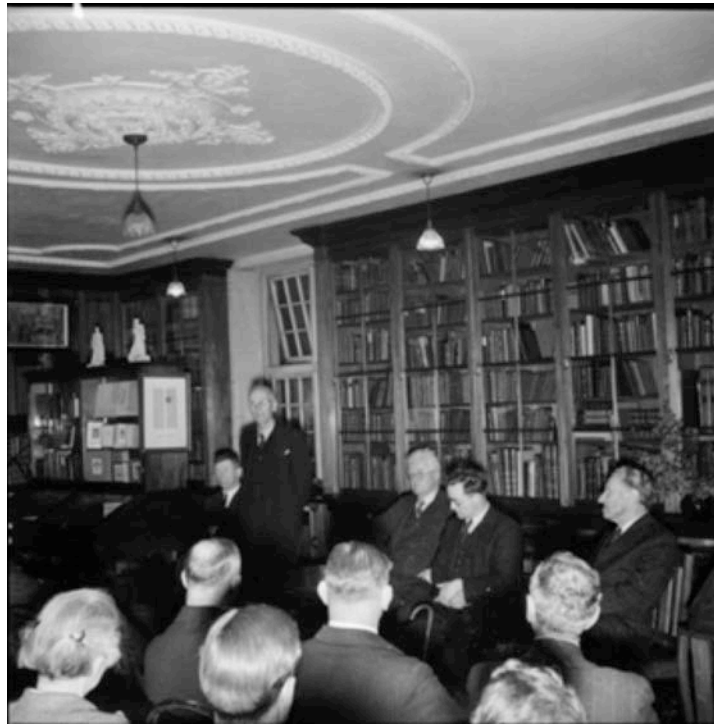
The 25th anniversary celebrations of the library, 1945. This image provides a good view of the decorative plaster ceiling and bookcases in the main room on the ground floor, by then the Exhibition Room. The then-retired first librarian Johannes Andersen, sits to the far right, and Taylor to the far left. The speaker is Minister for Internal Affairs W Parry, and to his right is the Secretary for Internal Affairs, J Heenan (John Pascoe image, 1/4-001819-F, ATL)

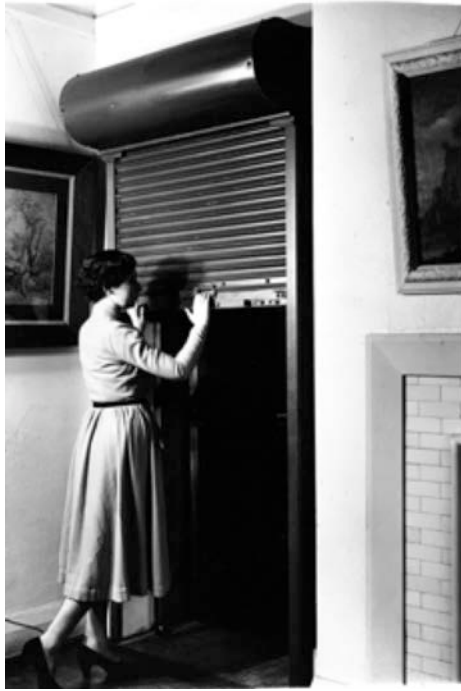
A fire-proof shutter door installed between the Art Room and the Rare Book Room on the ground floor. (56213½, ATL)

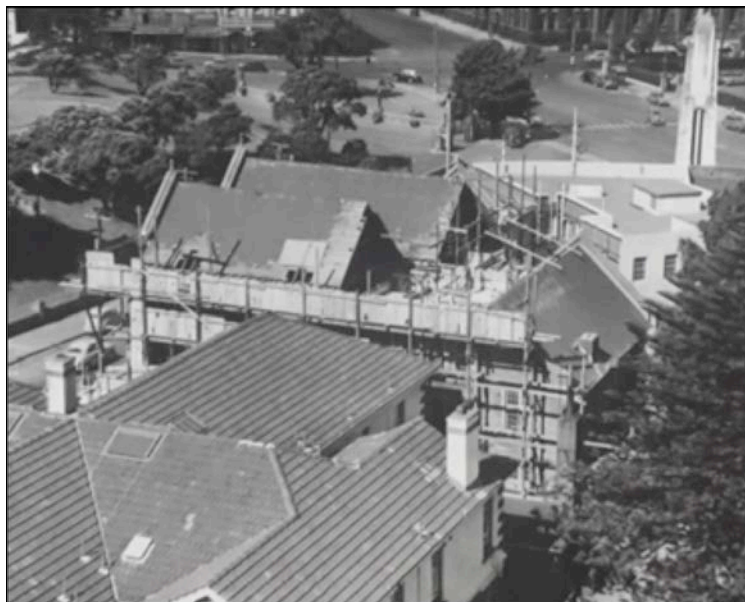
Structural strengthening of the library under way, with Bowen Hospital in the foreground. The fourth floor stack room and concrete “dome” has been removed and the roof is open.  
November 1955. (EP/1955/2469-F, ATL)

A new concrete strengthening band was installed just below the roof-line. An exterior steel frame strengthened the brick piers between the windows of the stack rooms. Bricks from the parapets were reused elsewhere in the building, as were slates. Galvanised spouting and downpipes were replaced with copper. One new window was added, into what had been the back bedroom at the first floor.<sup>41</sup> It seems likely that the steeply raked parapets of the outbuilding were also taken down at this time, and replaced with a flat roof with overhangs.

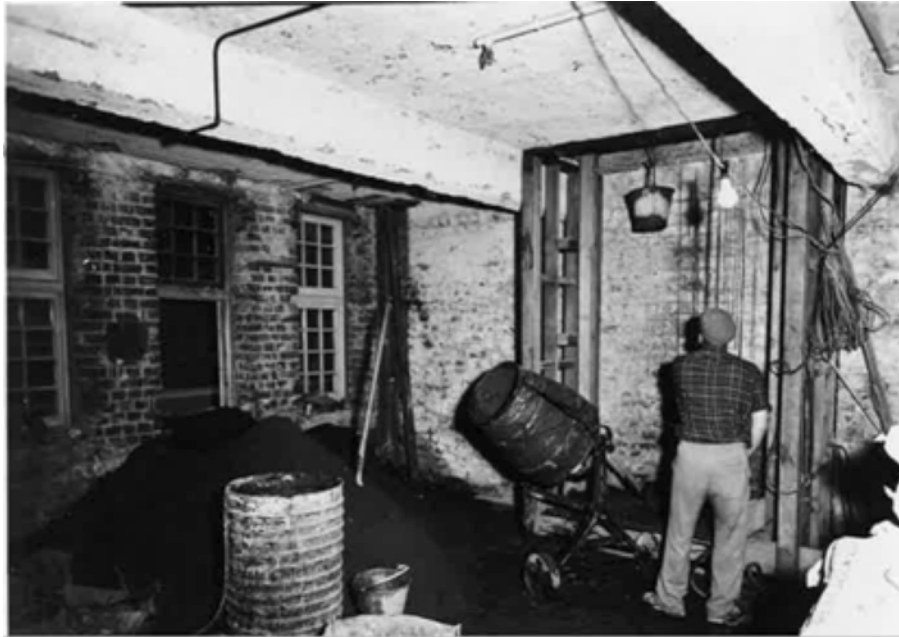
Remedial work under way, 1956. Image taken in one of the stack rooms. Note the walls taken back to the brick, and the timber-framed shaft for the book lift. (10932½, ATL)

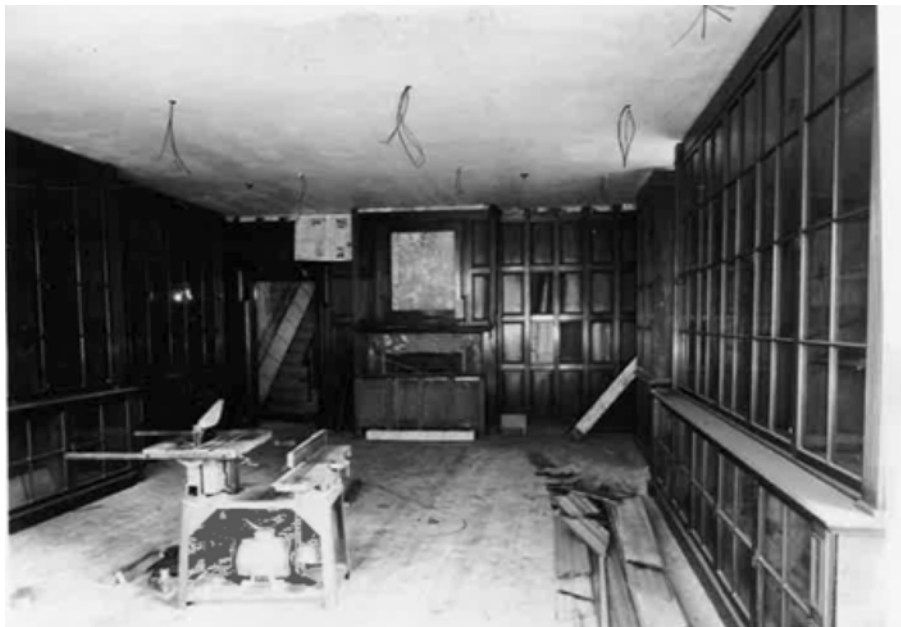
Image of the Reception Room. The decorative plaster ceiling has been replaced with flat fibrous plaster sheeting. (F10933½, ATL)

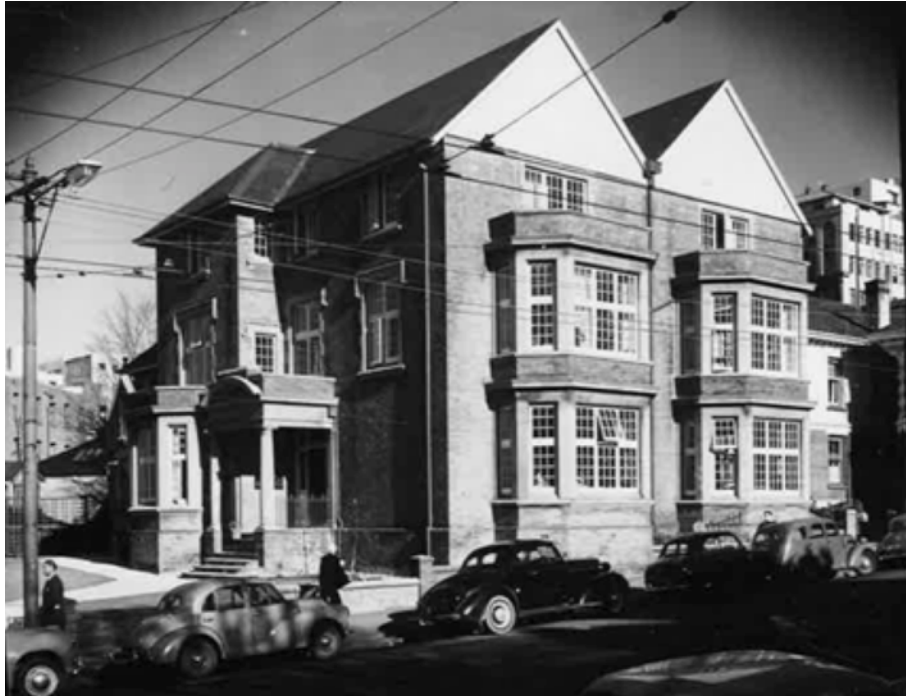
The building in 1958, following the completion of the remedial work. The roofline, decoration, and character of the building are starkly different from both the original and the form of the building today. (15624½, ATL)

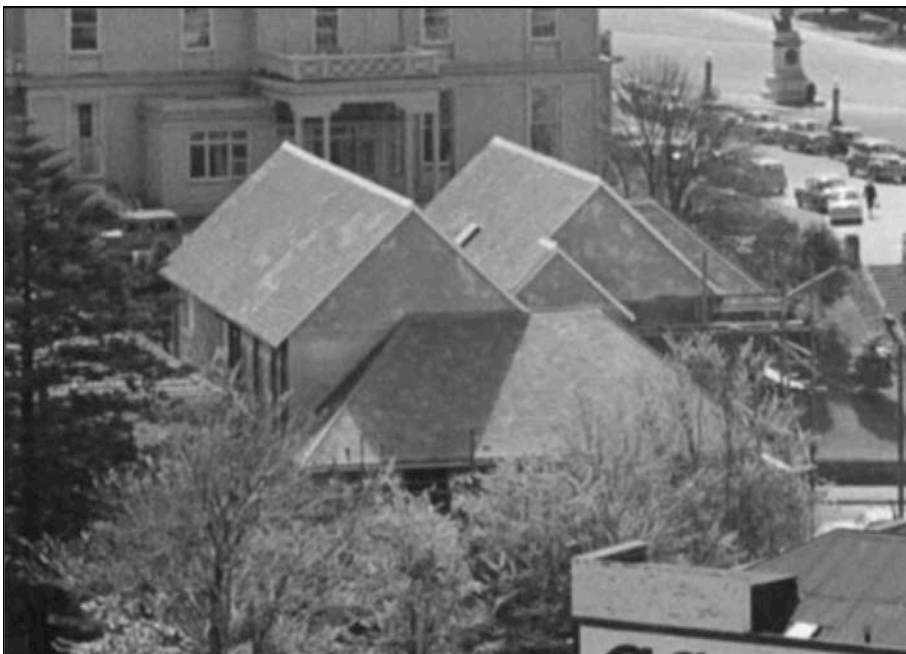
A view from the rear, the end stages of the remedial work with some scaffolding still in place. Old Government House (demolished in 1969 to make way for the Beehive) can be seen in the background. (Detail from *Evening Post* image EP/1956/2313-F, ATL)

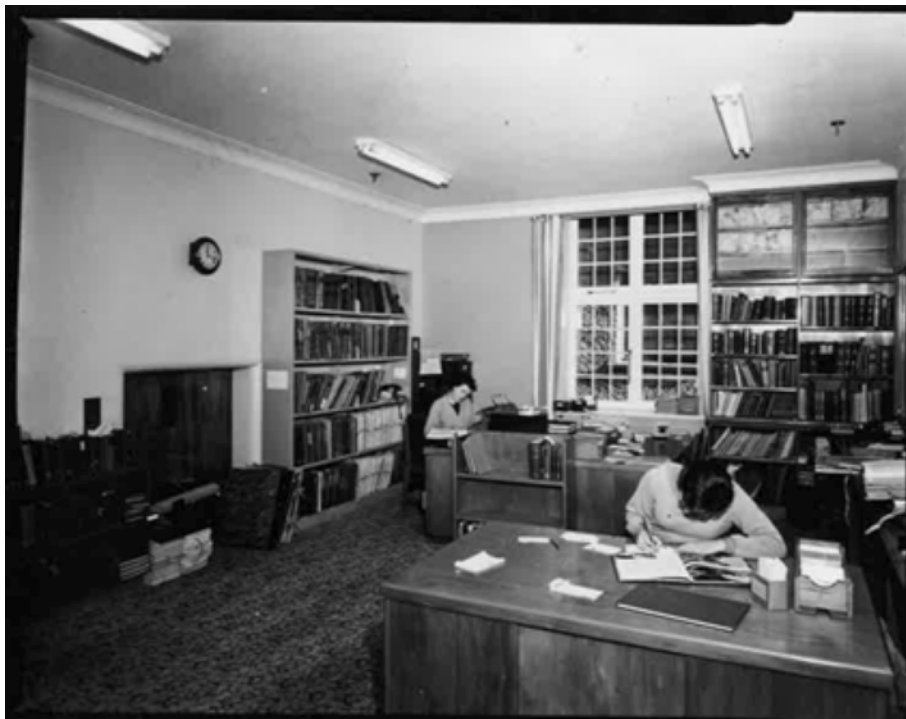
The Reference Librarian's Room, adjoining the Reading Room on the first floor. Note the book lift in the wall. Image ca. 1958 (15617½, ATL)

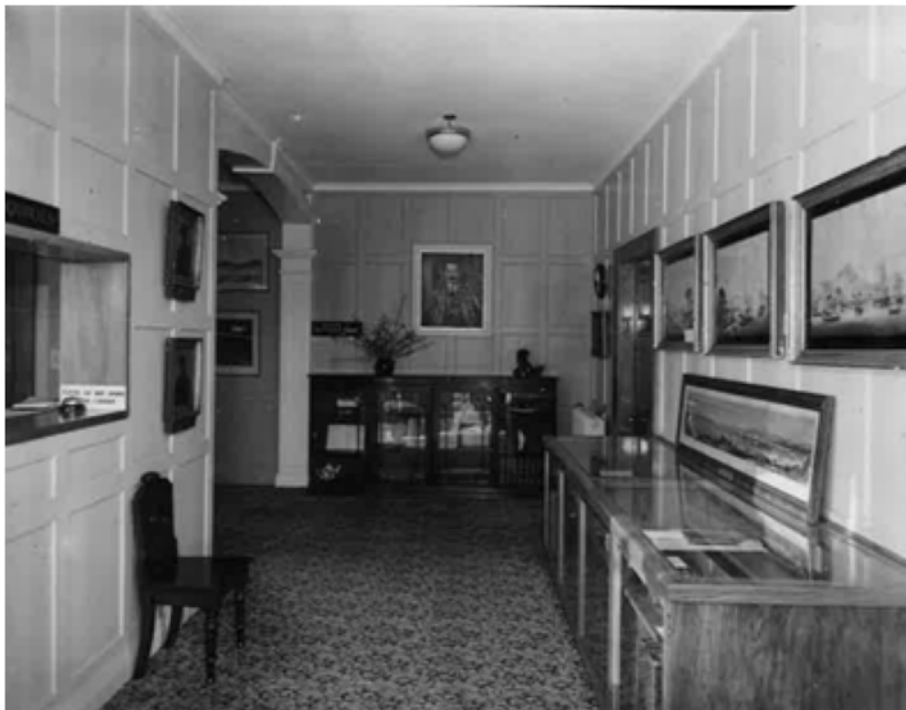
The main hall, ca. 1958, with Alexander Turnbull's portrait at the end. The cabinets in the hall seen in this image were built at this time. (15617½, ATL)

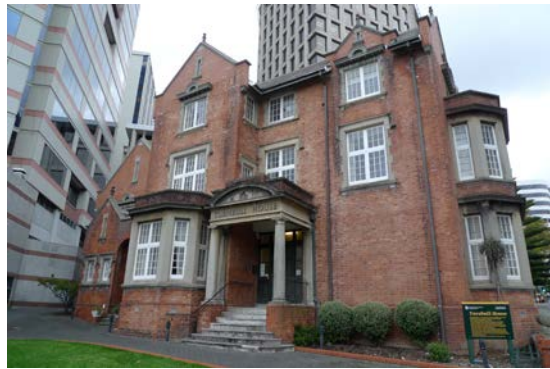
**Form of Building**  
**Heritage Value: 1**

The complex external form of the building is very much as it was when it was first constructed (less the chimney stacks removed in the 1950s, and the modification of the outbuilding roof) and the building has an exceptional level of physical and visual authenticity.

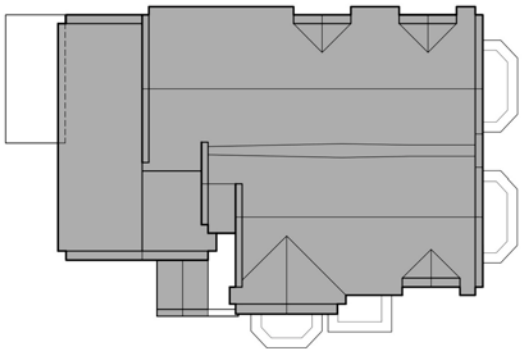
<b>Roofs</b> Heritage Value: 1

<b>Description</b>		
<b>Fabric</b>		
Roofing and flashings	Welsh slates, with copper flashings	1
Spouting and downpipes	Copper, some modern	1
“Balcony” roofs	Modern liquid-applied membrane	Nil
	Brick, concrete and plaster substructure	1
Original parapets	Plastered brick, with built-up mouldings	1
Modern parapets	Plastered polystyrene mouldings on timber frame	2
1950s gables	Stucco, on timber frame, with modern parapets	3
Modern gables	Brick veneer on timber frame	2
Outbuilding roof	Modern low-pitch membrane roof	Nil

The whole of the roof over the house must be preserved in its current form. This is partly the original fabric (as repaired and modified in the 1950s) and partly the 1995 reconstruction of its original form (gable ends etc.). Intervention should generally be limited to repair and maintenance, and other preservation work.

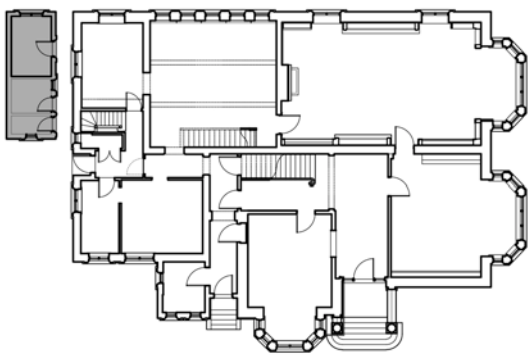
<b>Outbuilding</b> Heritage Value: 1

<b>History</b> <p>The Outbuilding was put up at the same time as the house and retains its original layout. The Boiler Room at the west end was originally the wash-house, with a copper. It was converted to run the radiator system in the 1950s renovation. A new gas boiler was installed for the radiators in 1978. The next space was the wood and coal store, which was used for sprinkler equipment in the 1950s work (this equipment was relocated under the main stair when the new sprinklers were installed in the late 1970s). The eastern space was originally a toilet, converted for storage in the 1950s.</p> <p>At some point the roof was flattened, and the parapets removed, probably in the 1950s. A new butynol roof was installed, most likely ca. 1995.</p>		
<b>Description</b> <p>The Outbuilding is a plain rectilinear structure, covered with a simple modern mono-slope roof, which appears to entirely cover the original roof and parapets. It is built and finished to match the house, with brick walls, moulded plaster window and door surrounds and timber door and window joinery. The south and west sides are surrounded by an elevated garden area. The interior spaces are plastered directly on the brickwork.</p> <p>Two of the interior spaces were not accessible for inspection.</p>

<b>Fabric</b>		
Roof	Modern butynol roof and supporting structure	Nil
Walls	Original brick walls, plaster window surrounds and timber door and window joinery	1
Interiors	Plastered concrete floor, plastered brick walls	1
	Modern fibrous plaster to ceilings	3

Aside from the roof, this structure has a very high level of authenticity and must be preserved in its current form. The roof could be returned to its original configuration with a 3-sided parapet (this would require raising the brick walls). Intervention should otherwise be limited to repair and maintenance, and other preservation work. This includes reinstating the missing window sash in the Boiler Room.

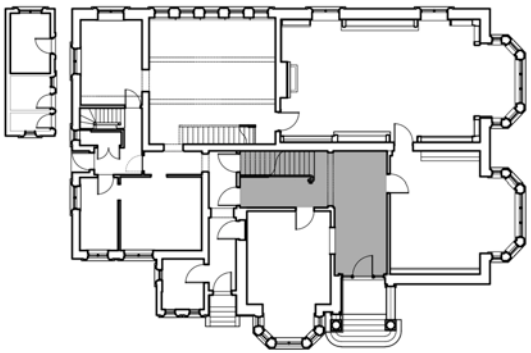
<b>Entrance Hall and Main Stair</b> Heritage Value: 1

<b>History</b> <p>This space has remained more or less unchanged since the building was constructed. In the 1940s-1970s the Treaty of Waitangi was housed here, in glass display cases, and there were many other pieces of art hanging on the panelled walls.</p>		
<b>Description</b> <p>This space is one of the most important in the building. It is the grand entry to the house, containing the main stair that rises through 3 levels, and it opens on to the main ground floor spaces. The space retains its original form and finish, except for the ceiling. The walls are panelled and painted, as they were originally, in contrast to the 6-panel doors and trims that remain clear finished (also as originally).</p>		
<b>Fabric</b>		
Ceilings	Modern fibrous plaster	3
Walls	Painted panelling, clear finished trims to doors, boxed timber arch and pilasters at foot of stair	1

Floor	Modern carpet	Nil
	Underlying timber strip flooring and structure	1
Joinery	Stair, with wrought timber rail and metal balustrading	1
	6-panel front door assembly, with glazed side- and top-lights	1
	6-panelled timber doors, clear finished	1
Other	Service hatch into Office	Nil
	Modern lights, sprinkler heads, alarm system	Nil

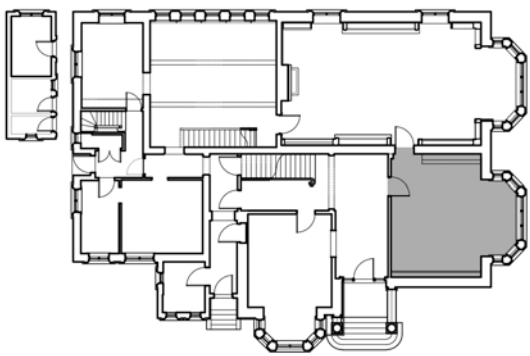
Ante Room  
(former Study)  
Heritage Value: 1

This room was originally Turnbull’s study. The original fireplace (and associated chimney-stack) was removed in the 1950s renovation.

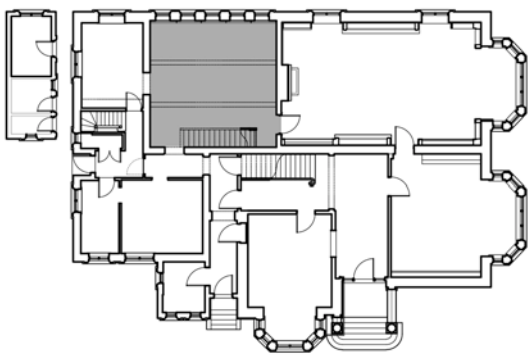
<div>Dining Room (former Stack Room) Heritage Value: 2</div>

<div>History</div> <p>This room was one of the four concrete-floored stack rooms set one above the other. Originally, the only accesses to the room were from the Rare Books Room, and the stack staircase.</p> <p>In the 1950s renovation the space became known as the Newspaper Room. A new opening was formed to the hall to improve access. A book lift was also installed, later removed in the 1990s. The archway entry into the Alcove was formed in 1978 and the room was used as the Pâté Shop Dining Room. During the DOC era this restaurant was renamed the Turnbull Café.</p>		
<div>Description</div> <p>This room retains its original form and distinctive array of five windows on the west wall. The stack stair remains in its original place, although it is blocked off at the ceiling level, and partly enclosed with a light partition.</p>

<div>Fabric</div>		
Ceilings	Plastered concrete beams and soffit, painted	1
Walls	Painted plaster	1
	Modern openings to Hall and Alcove	3
Floor	Modern carpet	Nil
	Underlying concrete floor	1
Joinery	West windows	1
	6-panelled timber door, clear finished	1
Other	Modern lights, sprinkler heads, drapes, radiators	Nil
	Stack stair	2
	Timber partition around Stack Stair	Nil
	Modern structural strengthening elements	Nil

This space should be kept in its current form. Intervention should generally be limited to repair and maintenance, and other preservation work.

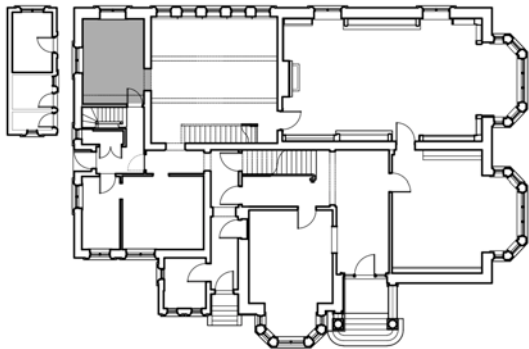
<b>Alcove</b> <b>(former Maid's Room)</b> Heritage Value: 2

<b>History</b>  Originally this was the Maid's Room, close to the servant's stair. The corner fireplace and chimney-stack were removed in the 1950s, and the room was known for a while as Stack-room 1 (the Dining Room then being Stack-room 2).  During the early Turnbull House Council era in 1970s, the Arts Council used it. From 1978 it became the part of the Pâté Shop's dining area, with an arched opening created to the main dining room.		
<b>Description</b>  This space remains more or less in its original form, less the original fireplace. There are two large windows, one on each external wall, and the curious arched opening to the Dining Room, as well as a panelled room door.		
<b>Fabric</b>		
Ceilings	Modern fibrous plaster and trims	3
Walls	Painted plaster	1
	Opening to Dining Room	Nil
Floor	Modern carpet	Nil
	Underlying timber floor	1

Joinery	Windows	1
	6-panelled timber door, clear finished	1
Other	Modern lights, sprinkler heads, drapes, radiators	Nil

This space should be kept in its present form. Intervention should generally be restricted to preservation work. To improve the appearance of the whole west elevation, the covers should be removed from the lower sashes of the windows (similarly remove covers from the south windows) and the top sash of the west window should be repaired with glazing bars let in to match the original pattern. To improve the authenticity of the space, the arched opening could be filled in.

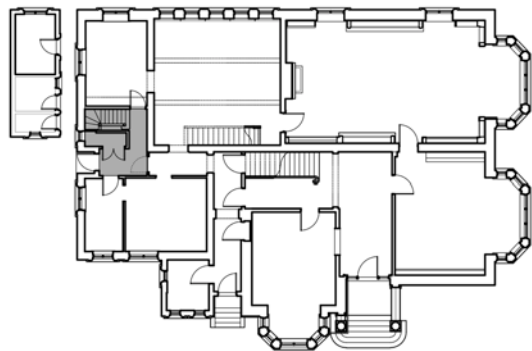
<b>Back Hall, Back Stair, and Service Porch</b> Heritage Value: 2

<b>History</b> The hallway was originally a single continuous space that connected the service door and back porch to the entrance hallway. This space remained more or less unchanged until ca. 1977, when a storage cupboard was built under the stair, projecting out into the hallway, and a door was added to divide off the main part of the hallway from the back stair. The service porch was then used as the accessible entrance to the building.		
<b>Description</b> This space contains the back stair, originally used by the houses' servants. This is an elegant piece of joinery with pointed newel posts and pierced balustrading, lit with a large window on the south wall. The modern pantry, an extended version of the original stair cupboard, intrudes into the space.		
<b>Fabric</b>		
Service porch	Brick walls and arched opening, plaster floor	1

Walls	Painted plaster	1
	Modern plasterboard	Nil
Floor	Timber floor and structure	1
Joinery	Windows at south wall	1
	6-panelled exterior door, with rectangular fanlight above	1
	6-panelled timber door, clear finished	1
	Staircase	1
Other	Modern lights, sprinkler heads	Nil
	Modern pantry and shelving	Nil

This space should be returned to its earlier form by the removal of the pantry. The hallway door could also be removed to reinstate the original form of the hallway. The servant's stair must be retained in its current form. Intervention should otherwise be generally restricted to preservation work.

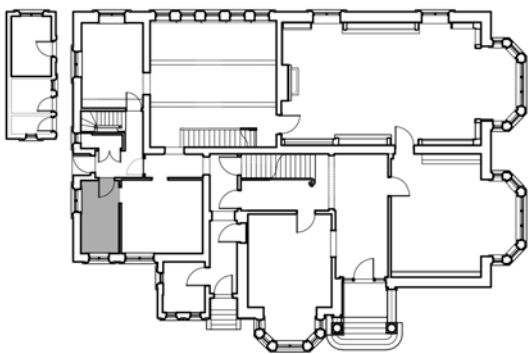
<div>Prep Room (former Scullery and Larder) Heritage Value: 3</div>

<div>History</div> <p>This room was the part of the original kitchen area, divided into scullery and larder. A large pantry, accessed from the kitchen side, projected into the larder space. In the 1950s renovation the kitchen space was converted to a staff room, the larder removed. The enlarged space was made into a staff kitchen. In the 1970s renovation the original kitchen was returned to service, and the scullery was reinstated as a prep room.</p>		
<div>Description</div> <p>This space is quite modified from its original form. It is lit by two small windows, one on each external wall, and contains modern kitchen joinery and fixtures.</p>		
<div>Fabric</div>		
Ceilings	Modern fibrous plaster and trims	3
Walls	Painted plaster	1
	Modern plasterboard	Nil
Floor	Modern vinyl	Nil
	Underlying timber floor	1
Joinery	Windows	1
	6-panelled timber door, clear finished	1

Other	Modern lights, sprinkler heads, benches, cupboards, sinks and hand-basin and other fittings	Nil

The original door and window joinery must be preserved. The modern kitchen fittings and fixtures could be stripped out, and the room could be adapted for other uses.

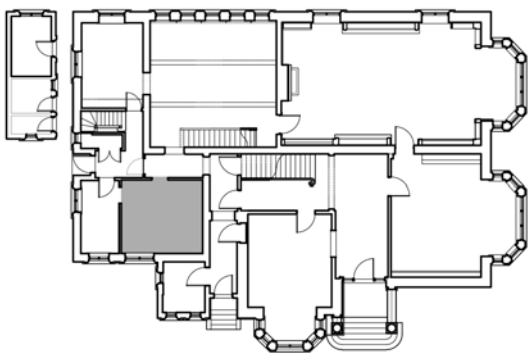
<b>Kitchen</b> Heritage Value: 3

<b>History</b> <p>This room was the original kitchen, opening through to the scullery space.</p> <p>Prior to the 1950s renovation the original coal range had been removed; later, the kitchen space was converted to a staff room and the scullery to a staff kitchen. In the 1970s the Arts Council used the staff room, probably as an office.</p> <p>In the 1970s renovation the kitchen was returned to service as a commercial kitchen, associated with the Pâté Shop (and later the Turnbull Café) between 1978 and 2012, and the scullery was used as the prep room.</p>		
<b>Description</b> <p>This space is quite modified from its original state, although it retains its original walls. It is lit by a single large window and currently contains modern commercial kitchen joinery and fixtures.</p>		
<b>Fabric</b>		
Ceilings	Modern fibrous plaster and trims	3
Walls	Painted plaster	1

Modern plasterboard	Nil
Floor	Modern vinyl	Nil
	Underlying timber floor	1
Joinery	Windows	1
	6-panelled timber door, clear finished	1
Other	Modern lights, sprinkler heads, extract hood benches, cupboards, sinks and hand-basin and other fittings	Nil

The original door and window joinery must be preserved. The modern kitchen fittings and fixtures could be stripped out, and the room could be adapted for other uses.

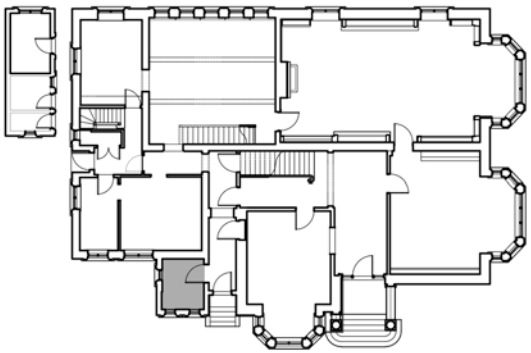
<b>Accessible WC</b> Heritage Value: 2

<b>History</b> This space was originally a staff toilet, located beside the kitchen; it was converted into an accessible toilet ca. 1995, which involved removing the original partitioning and installing new fixtures.		
<b>Description</b> The room retains its original shape.		
<b>Fabric</b>		
Ceilings	Modern fibrous plaster	3
Walls	Painted plaster	1
Floor	Modern vinyl	Nil
	Underlying timber floor	1
Joinery	Windows	1
	6-panelled timber door, clear finished	1
Other	Modern lights, sprinkler heads, and toilet fittings	Nil

The overall form of the space should be retained, along with the original window and door joinery, but it could be modified or adapted to other uses.

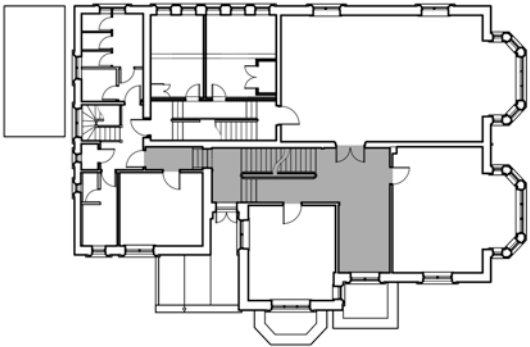
<b>First Floor Hall, and Main Stair</b> Heritage Value: 1 (HV3 for former bathroom area)

<b>History</b> Turnbull's bathroom originally occupied the northern return of this space (see <i>Turnbull Room</i> , following). In the early library era the space was converted into the Reference Room. In the 1950s renovation, the wall between bathroom and hall was removed, and the space was put to use as a cataloguing area.		
<b>Description</b> This hall is a continuation of the grand entry space to the house, containing the main stair, and opening on to the main first floor spaces, and is of similar importance as the main hall. The walls of the hall are panelled and painted, following the style and pattern of the entry hallway below. The arch at the south leads up 3 steps into a short extension of the hall. A narrow set of French doors lets out onto the terrace area at the east, and the window at the far east end of the space opens out over the balcony above the portico.

<b>Fabric</b>		
Ceilings	Modern fibrous plaster and trims	3
	Battened ceiling at south end	1
Walls	Painted timber panelling, clear finished trims to doors	1
Floor	Modern carpet	Nil
	Underlying timber strip flooring and structure	1
Joinery	Stair, with wrought timber rail and metal balustrading	1
	6-panelled timber doors, clear finished	1
	Modern glazed doors to gallery spaces	3
Other	Modern lights, sprinkler heads, radiators	Nil

This space should be retained in its current form and intervention should generally be limited to repair and maintenance, and other preservation work. The line of the former bathroom wall could be reinstated if desired to return the hallway to its original proportions.

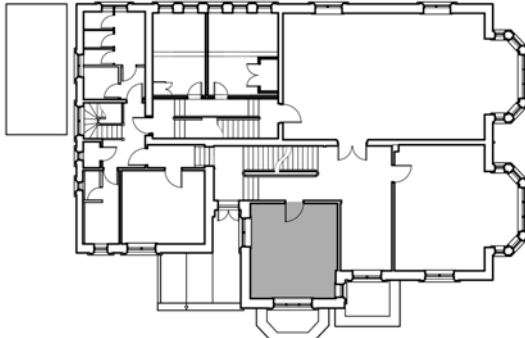
<b>Turnbull Room</b> (former Dressing Room and Work Room) Heritage Value: 3

<b>History</b> <p>In the original plans this area off the stair landing contained five spaces. These were: Turnbull’s bathroom (which occupied the area of the present return to the landing), a dressing room, a small passage accessed from the bathroom and from the hall, a small toilet, and lastly a separate Work Room accessed from the hall.</p> <p>At some point during the library era the toilet was removed, and the dressing room and work room were joined together. During Taylor’s time as Librarian this became his office. In the 1950s renovations the remaining partitions were removed and a new partition was added in the Librarian’s room (Taylor’s office) so that this room took on the dimension it is now, as the Turnbull Room, and the extended hallway became the cataloguing area, as noted above. For a number of years this was known as the Wellington Embroiderers’ Guild Room, although it is most recently known as the Turnbull Room.</p>

<b>Description</b> <p>This room bears only a passing resemblance to its original configuration. The eastern window gives access to the balcony roof above the dining room; the southern window looks out over the terrace, and there is a small window on the northern wall.</p>		
<b>Fabric</b>		
Ceilings	Modern fibrous plaster and trims	3
Walls	Painted plaster	1
	Plasterboard	Nil
Floor	Modern carpet	Nil
	Underlying timber strip flooring and structure	1
Joinery	Timber windows	1
	6-panelled timber door, clear finished	1
Other	Modern lights, sprinkler heads, drapes, radiators	Nil

This space has a relatively low level of authenticity, and could be adapted for other uses without adverse impact on heritage values.

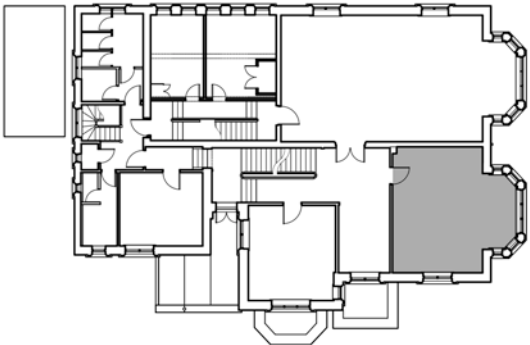
<div>Small Gallery (former Main Bedroom) Heritage Value: 1</div>

<div>History</div> <p>This was originally Alexander Turnbull’s bedroom, which had an ensuite bathroom and dressing room. In the early library era this was used for New Zealand books and housed a cabinet that held large illustrated books and Antarctic sketches. The original fireplace (and chimney) was removed in the 1950s renovations and the space became the Work Room, which was used for accessioning etc.</p> <p>In the 1970s, after the library left, this became the ‘Exhibition Room’. At some point, this room was named the Small Gallery, and used regularly as a meeting room and gallery. Track lighting was added during DOC era.</p>																										
<div>Description</div> <p>This room retains its original form, aside from the door to the original ensuite. The main feature of the space is the substantial bay window looking out to Bowen Street. There is also a window on the east wall, overlooking the garden. It remains one of the more important rooms in the house.</p>																										
<div>Fabric</div>

<table><tr><td>Ceilings</td><td>Modern fibrous plaster and timber trims</td><td>3</td></tr></table>

This space should be retained in its present form. Intervention should generally be restricted to restoration work.

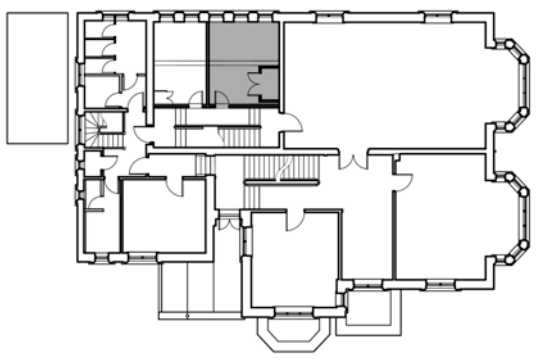
<div>Store</div> <div>(part of former Stack Room 3)</div> <div>Heritage Value: 3</div>

<div>History</div> <p>This room was part of the original Stack Room 3. A book lift was installed during the 1950s renovation to service the stack rooms. In a 1970s plan this space was labelled Store Room. During at least part of the library era this space was known as the Manuscripts room. The lift was removed in the 1990s and the stack room was subdivided with timber-framed walls, to form the present Store, Tenant’s Kitchen and Stack Stair spaces, and the stack stair descending to the Dining Room (former Stack Room 1) was sealed off at floor level.</p>		
<div>Description</div> <p>The original space followed the arrangement of the Dining Room below. The subdivided space contains 3 of the row of 5 windows and a built-in cupboard, made out of the former book lift shaft.</p>		
<div>Fabric</div>		
Ceilings	Plastered concrete beams and soffit, painted	1

Walls	Painted plaster	1
	Timber partitions to Tenant’s Kitchen and Stack Stair, built-in cupboard	Nil
Floor	Modern vinyl	Nil
	Underlying concrete floor	1
Joinery	West windows	1
	6-panelled timber door, clear finished	2
Other	Modern lights, sprinkler heads, drapes, radiators	Nil
	Modern structural strengthening elements	Nil

This group of spaces formed from the original stack room could be joined back together to the original configuration, or otherwise adapted to a new use.

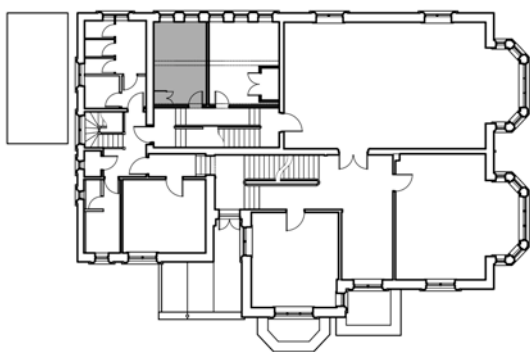
<b>Tenant's Kitchen</b> (part of former Stack Room 3) Heritage Value: 3

<b>History</b> This room was part of the original Stack Room 3, which was subdivided in the 1990s. The kitchen joinery was recycled from the former tenant's kitchen on this floor (which was in the present Men's Toilet area), and the room door came from the ground floor level.		
<b>Description</b> The subdivided space contains 2 of the row of 5 windows and a hot water cupboard, as well as the kitchen joinery, fixtures and fittings.		
<b>Fabric</b>		
Ceilings	Plastered concrete beams and soffit, painted	1
Walls	Painted plaster	1
	Timber partitions to Tenant's Kitchen and Stack Stair, built-in cupboard	Nil
Floor	Modern vinyl	Nil
	Underlying concrete floor	1
Joinery	West windows	1
	6-panelled timber door, clear finished	2
Other	Modern lights, sprinkler heads, drapes, radiators, kitchen joinery, fittings and fixtures.	Nil
	Modern structural strengthening elements	Nil

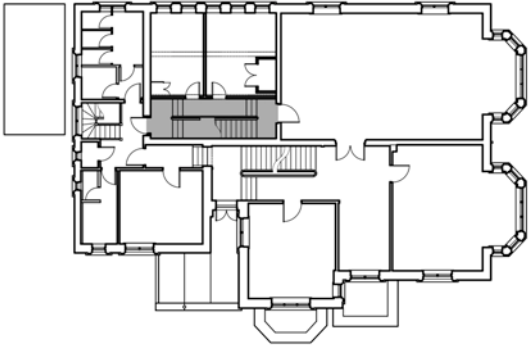
<b>Stack Stair</b> (part of former Stack Room 2) Heritage Value: 3

<b>Description</b> This subdivided space contains the stack stair; it joins to the Large Gallery at the north and the Back Hall at the south. The stairs are concrete; the descending flight is blocked off at floor level, and the ascending flight rises to the New Zealand Portrait Gallery.		
<b>Fabric</b>		
Ceiling	Plastered concrete stair soffits	1
Walls	Plastered brick walls	1
	Timber-framed walls	Nil
Floor	Concrete floor	1
	Timber framed infill floor to below	Nil
	Modern vinyl floor coverings	Nil
Stairs	Concrete stairs, with wrought timber handrail and metal balustrade	1
Other	Old electrical conduit	3
	Surface mounted services, fire hose reel, modern stair nosings	Nil

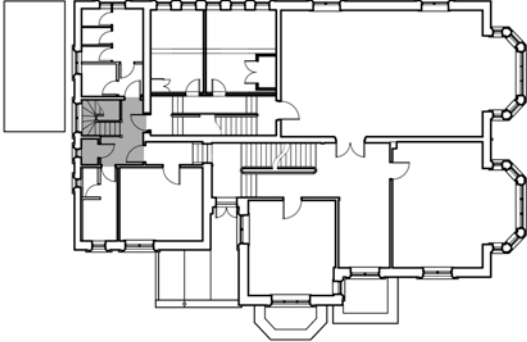
Landing, Back Stair and Cleaner Heritage Value: 2

<b>History</b> The landing originally let on to the bathroom, toilet and store-room and the two back bedrooms. There were also two linen cupboards. The cleaner’s cupboard was originally a store and had built in shelving; in the 1950s renovation this became a stationary cupboard, and it was converted to its present use in the 1990s.		
<b>Description</b> This is a circulation space providing access to the main service spaces in the building. It is utilitarian, except for the back stair, which is an elegant piece of joinery with pointed newel posts and pierced balustrading, and the large southern window which floods the area with light.		
<b>Fabric</b>		
Ceilings	Modern fibrous plaster and timber trims	3
Walls	Painted plaster	1
	Timber-framed walls with plasterboard linings	1
Floor	Modern carpet	Nil
	Underlying timber strip flooring and structure	1

Joinery	Window to south wall	1
	Staircase	1
	6-panel doors, clear finished	3
Other	Modern lights, sprinkler heads, drapes, fire extinguisher.	Nil

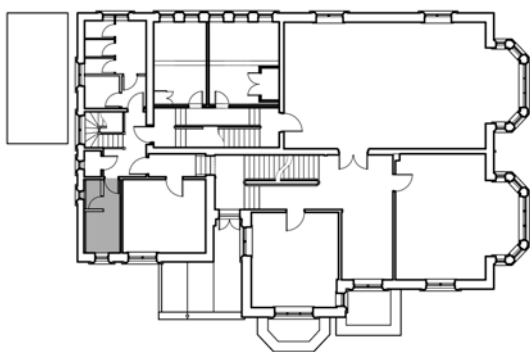
<b>Male Toilets</b> Heritage Value: 3

<b>History</b> Originally this space contained a small bathroom for servants and/or guests. It had a bath and basin, a separate toilet, and a small lobby. In the 1950s renovations this area was rearranged to make a consolidated men’s toilet facility. The old toilet was made into a cleaner’s cupboard. In the 1970s these spaces were converted into a kitchen for the use of the tenants using the first floor rooms. In the 1990s the tenant kitchen was moved to its present location, and the space was transformed into the present men’s toilets			
<b>Description</b> This is an entirely utilitarian space, much modified from its original configuration. The toilet partition is part-height. The space is lit with windows on the south and east walls.			
<b>Fabric</b>			
Ceilings	Modern fibrous plaster and timber trims		3
Walls	Painted plaster		1
	Timber-framed walls with plasterboard linings		Nil

Floor	Modern vinyl		Nil
	Underlying timber strip flooring and structure		1
Joinery	Windows to both walls		1
	6-panel door, clear finished		Nil
Other	Toilet partitions, fittings and fixtures including, hand-basins, toilet pan, urinals etc.		Nil
	Modern lights, sprinkler heads and the like.		Nil

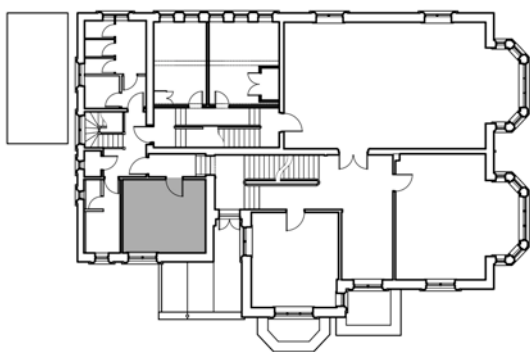
<b>Friends of Turnbull Library</b> <b>(former Bedroom)</b> Heritage Value: 2

<b>History</b> <p>This room was originally built as a bedroom, and had a fireplace and a built-in cupboard. The fireplace and chimney-stack was removed in the 1950s renovation. Later in the library era this room became the Assistant Librarian’s office. It was then used as the Friends of the Turnbull Library Room from the 1970s.</p>		
<b>Description</b> <p>The space retains its original form, but little of its original finish. It is lit by a single window on the east wall.</p>		
<b>Fabric</b>		
Ceilings	Modern fibrous plaster and timber trims	3
Walls	Painted plaster	1
	Plasterboard	3
Floor	Modern carpet	Nil
	Underlying timber strip flooring and structure	1
Joinery	Window	1
	Glazed door, clear finished	3
Other	Modern lights, sprinkler heads, drapes, radiators	Nil

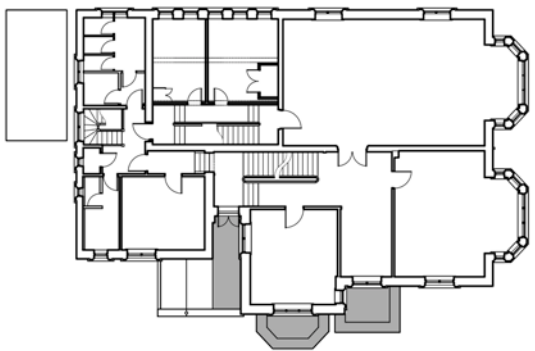
<b>Balconies and Terrace</b> Heritage Value: 1

<b>Description</b> <p>The two balconies are accessed through windows in each case. One balcony is over the bay window of the office, the other over the portico. The terrace is a small open area, flanked by high walls on either side and looking out over the garden to the east; it was intended as a fire escape route on the original drawings.</p> <p>The east edge of the terrace and both balconies are delineated by brick balustrades, with moulded plaster copings, and have concrete floors overlaid with a modern waterproof membrane.</p> <p>These are all important architectural elements of the house.</p>		
<b>Fabric</b>		
Terrace	Brick balustrade with moulded plaster cap, brick side walls, slate roof above ground floor toilet, concrete sub-structure	1
Balconies	Brick balustrade walls, with moulded plaster copings	1
	Underlying concrete floor	1
	Modern waterproofing membrane	Nil

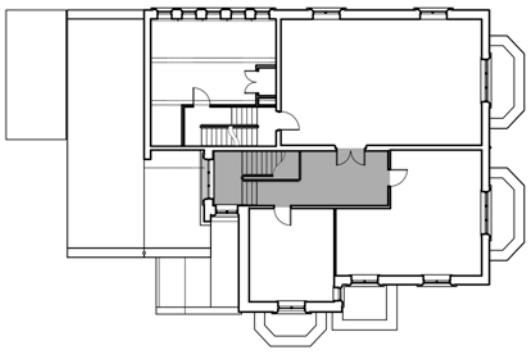
<b>Second Floor Hall and Main Stair</b> Heritage Value: 2

<b>Description</b> <p>This is the uppermost of the main public spaces of the building, containing the top flight of the main stair; it retains its original form. The south end of the space is lit with a large window on the south wall and a smaller window on the east wall, but the hall is otherwise internal. It opens to the three main rooms. The finishes in this space are all modern, dating to the 1950s and 1970s work, but it remains an important space.</p>		
<b>Fabric</b>		
Ceilings	Modern fibrous plaster and timber trims	3
Walls	Painted plaster	1
	Plasterboard, with timber battens	3
	Low dado to stair landing	1
Floor	Modern carpet	Nil
	Underlying timber strip flooring and structure	1
Joinery	Stair, with wrought timber rail and metal balustrading	1
	Windows to south and east walls	1
	Glazed room doors, clear finished	3
Other	Modern lights, sprinkler heads, drapes, radiators	Nil

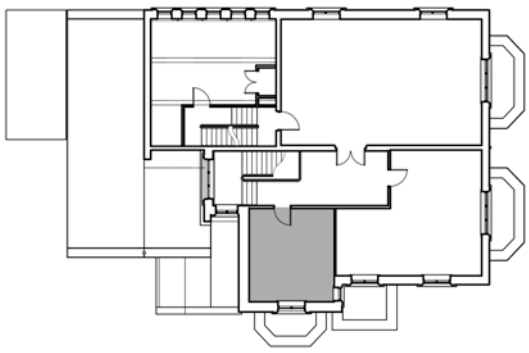
<b>Numismatic Society</b> <b>(former Bedroom)</b> Heritage Value: 2

<b>History</b> <p>This room was formed out of three original spaces in the 1950s renovation: a bedroom, passage, and a small toilet. The bedroom had a fireplace, which was removed, as was the toilet. The re-shaped space became the Map Room and presumably remained in this role until the library left in the 1970s. It was marked 'Committee Room' in a 1970s plan. For many years this space was used by the Numismatic Society</p>		
<b>Description</b> <p>This small room entirely reflects its last occupants, and bears little resemblance to its original configuration. It is lit with two windows, a small one to the north and a larger window looking out to the east, and has modern built-in timber cabinets and joinery.</p>		
<b>Fabric</b>		
Ceilings	Modern fibrous plaster and timber trims	3
Walls	Painted plaster	1
	Plasterboard	3
Floor	Modern carpet	Nil

Underlying timber strip flooring and structure	1
Joinery	Window, east wall	1
	Glazed room door, clear finished	Nil
	Display cases and shelving	3
Other	Modern lights, sprinkler heads, drapes, radiators	Nil

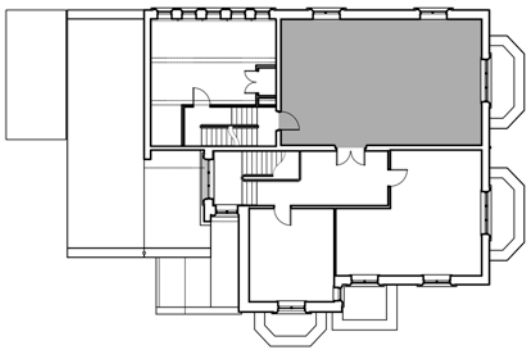
<b>Museum Room</b> Heritage Value: 1

<b>History</b> <p>In the early years of the library this was known as the English Literature Room, with ‘more modern writers and with the theatrical collection and other material’. During the renovations in the 1950s the fireplace was removed. After the 1950s work, the library was banned from using this room for stacks, and it became Exhibition Room 3. New book-cases were built to line the room.</p> <p>In a plan of the building drawn in 1976 it was labelled ‘Main Exhibition Room for National Museum’, although it does not seem to have been used for this purpose. It was used for meetings and the like during the Turnbull House Council and DOC eras</p>		
<b>Description</b> <p>This library room follows the footprint the large rooms on the two floors below, except there is no bay window. The north window opens out to a balcony above the bay window. The two windows on the west wall align with the windows below; the door in the south wall lets on to the stack stair. It is fitted out with modern built-in cabinets along each wall. It is the most important of the second-floor spaces.</p>

<b>Fabric</b>		
Ceilings	Modern fibrous plaster and timber trims	3
Walls	Painted plaster	1
Floor	Modern carpet	Nil
	Underlying timber strip flooring and structure	1
Joinery	Windows to north and west walls	1
	Glazed room doors, clear finished	Nil
	6-panel door to stack stair	1
	Display cases and shelving	3
Other	Modern lights, sprinkler heads, drapes, radiators	Nil

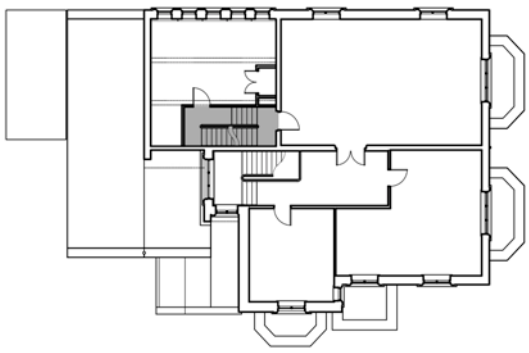
<b>Stack Stair</b> Heritage Value: 3

<b>Description</b> <p>The stack stair was divided off from the third-floor stack room in the 1950s renovation. The stairs are concrete; the ascending flight is blocked off at the ceiling level and a manhole at the top provides access into the roof space (Attic 2). The space is entirely internal.</p>		
<b>Fabric</b>		
Ceiling	Plastered concrete stair soffits	1
Walls	Plastered brick walls	1
	Timber-framed partitions	Nil
Floor	Concrete floor	1
	Timber framed infill to top of stair	Nil
	Modern vinyl floor coverings	Nil
Stairs	Concrete stairs, with wrought timber handrail and metal balustrade	1
Joinery	Glazed door to NZ Portrait Gallery room	3
Other	Old electrical conduit	2
	Surface mounted services, modern stair nosings	Nil

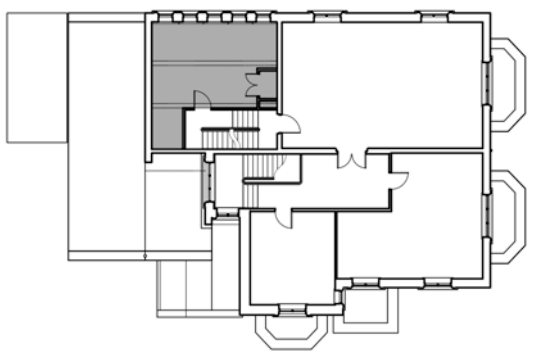
<div>NZ Portrait Gallery (former Stack Room) Heritage Value: 3</div>

<div>History</div> <p>After the 1950s renovations, this became the Manuscript (MSS) Room. A book lift was added and the stack stair-case was boxed in, making the room smaller. The book lift machinery occupied the space above (formerly the fourth floor stack room).</p> <p>The room was leased on a permanent basis to the Wellington Branch of the NZHPT in 1983, as a record and meeting room. It had vacated by 1997 and the room was empty for some years until the NZ Portrait Gallery leased the room, a lease that continued up until the closure of the building in 2012, even after the organisation’s new gallery was set up on the waterfront.</p>		
<div>Description</div> <p>This room is the third of the series of four concrete stack rooms; it was accessed from the Museum Room in front and also via the stack staircase from the room below. The array of five windows on the west wall aligns with the windows in the other stack rooms below. There is a built-in cupboard on the north wall, which has been formed out of the remnants of the book lift shaft.</p>

<div>Fabric</div>		
Ceilings	Plastered concrete beams and soffit, painted	1
Walls	Painted plaster	1
	Timber-framed partitions	Nil
Floor	Modern carpet	Nil
	Underlying concrete floor	1
Joinery	West windows	1
	Modern glazed door, clear finished	3
Other	Modern lights, sprinkler heads, drapes, radiators	Nil
	Built-in cupboard	Nil

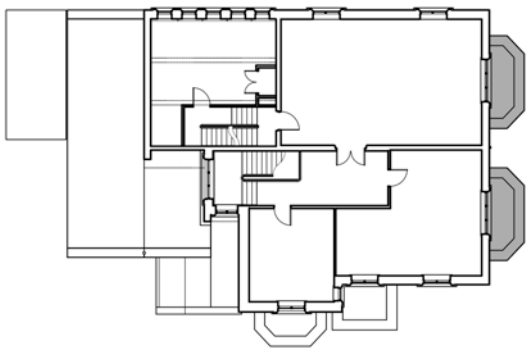
<b>Balconies</b> Heritage Value: 1

<b>Description</b> <p>The two balconies are accessed through windows in each case; each balcony surmounts a two-storeyed bay window.</p> <p>Brick balustrades, with moulded plaster copings, delineate the balconies; the balconies have concrete floors overlaid with a modern waterproof membrane.</p> <p>The balconies are critically important architectural elements.</p>		
<b>Fabric</b>		
Balconies	Brick balustrade walls, with moulded plaster copings	1
	Underlying concrete floor	1
	Modern waterproofing membrane	Nil

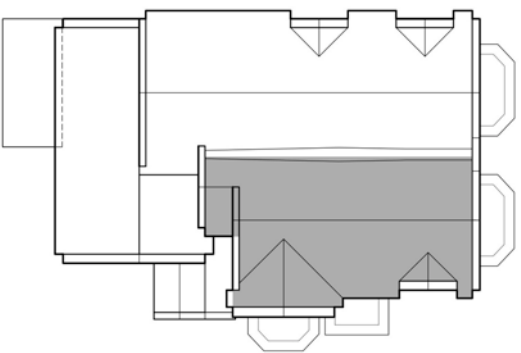
<b>Attic 1</b> Heritage Value: 3

<b>Description</b> <p>This roof space is accessed from a hatch in the 2<sup>nd</sup> floor Hallway. It is an oddly shaped volume, with part of the small gable on the east accessible, through a rough opening in the sarking; at the south end there is a half-gable, and the full gable end on the east face is also open into this space. On the west, an access hatch opens out to the internal gutter between the two main roofs.</p>		
<b>Fabric</b>		
Roof structure	Original timber framing, including ridge board, rafters, underpurlins, collar ties, sarking and the like	1
Walls	Original timber-framed gable end wall to south, diagonal sarking	1
	Modern timber-framed gable end wall to north	Nil
Ceiling plane	Modern ply lining	Nil
	Underlying original ceiling framing	1
Other	Various services including sprinkler piping, conduit and electrical cabling	Nil

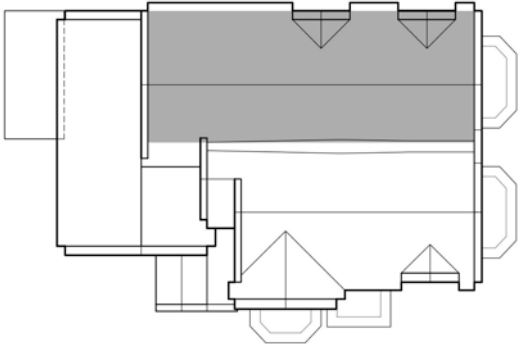
<b>Attic 2</b> Heritage Value: 3

<b>Description</b> This space is accessed via a manhole at the very top of the Stack Stair. It is a single large volume, once partly occupied by the fourth-floor stack room. The modern framing of the north wall is visible; the two small gable roofs to the west have been built on top of the sarking.		
<b>Fabric</b>		
Roof structure	Original timber framing, including ridge board, rafters, underpurlins, collar ties, sarking and the like	1
Walls	1950s timber-framed gable end wall to south, diagonal sarking (clad with stucco)	3
	Modern timber-framed gable end wall to north	Nil
Ceiling plane	Modern ply lining	Nil
	Underlying original ceiling framing	1
Other	Various services including sprinkler piping, conduit and electrical cabling	Nil

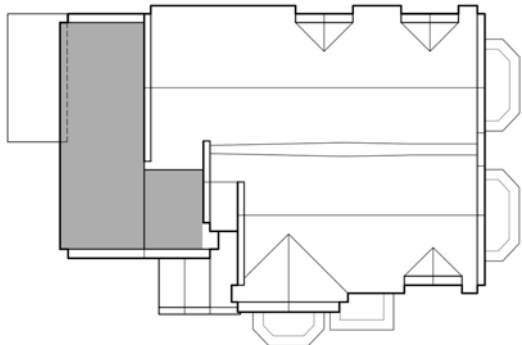
<b>Attic 3</b> Heritage Value: 3

<b>Description</b> This roof space is accessed from the top landing of the Back Stair. It is an L-shape in plan, with the back lean-to roof meeting into a brick wall on the north.		
<b>Fabric</b>		
Roof structure	Original timber framing, including ridge board, rafters, underpurlins, collar ties, sarking and the like	1
Walls	Brick wall on north side	1
	Modern timber-framed gable end walls to west and east	Nil
Ceiling plane	Modern ply lining	Nil
	Underlying original ceiling framing	1
Other	Various services including sprinkler piping, conduit and electrical cabling	Nil
